Waituna Lagoon Visual assessment of drain cleaning activities

March 2012

Dean Olsen, B.Sc.(Hons.), Ph.D.

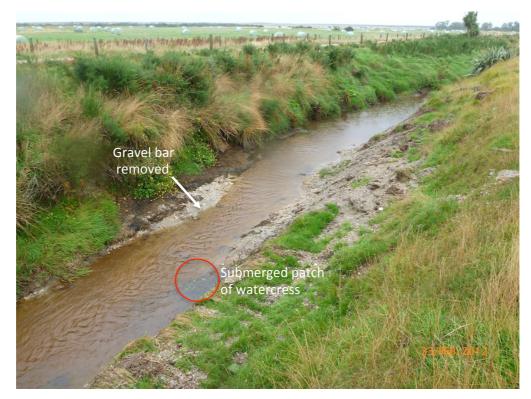
Waituna Creek near Mahers Tributary, has a moderate-sized channel with a bed predominantly of gravels and fine material. The section visited had been cleaned prior to the site inspection. Generally, there was relatively limited damage to the banks observed during the site visit, with some areas of localised disturbance evident (*Figure 2, Figure 3, Figure 5*). However, there were some exceptions to this where extensive bank remodelling had been undertaken (*e.g. Figure 6*).

*Figure 2* Waituna Creek near Mahers Tributary showing an area where a gravel bar has been removed, a submerged patch of watercress, and some localised bank disturbance.

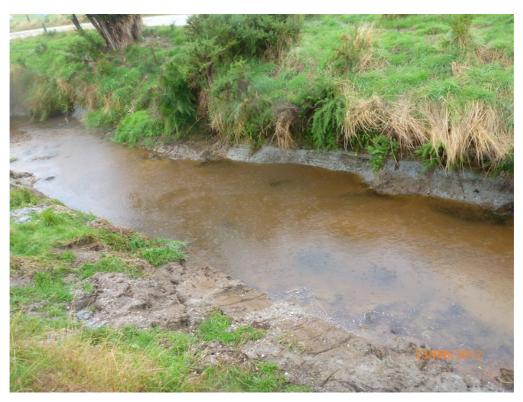
Figure 3

Waituna Creek near Mahers Tributary showing an area of localised bank disturbance.

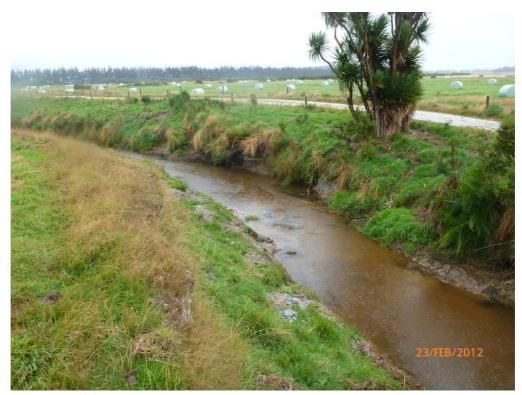
*Figure 4 Waituna Creek near Mahers Tributary showing a recently cleaned section.*

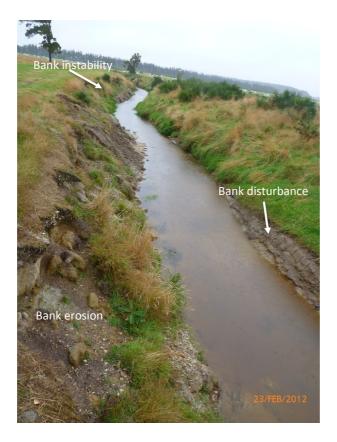
*Figure 5* Waituna Creek near Mahers Tributary showing an area of localised bank disturbance caused by drain cleaning and an unstable and eroding bank.

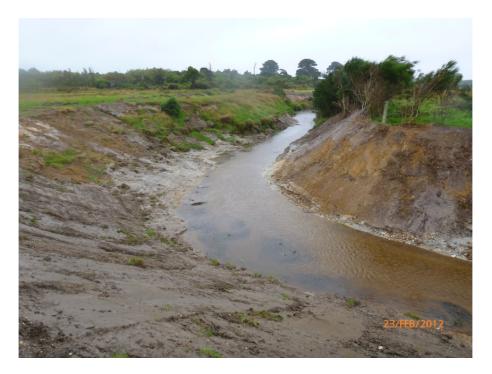
*Figure 6 Waituna Creek near Mahers Tributary showing an area of extensive earth works.*

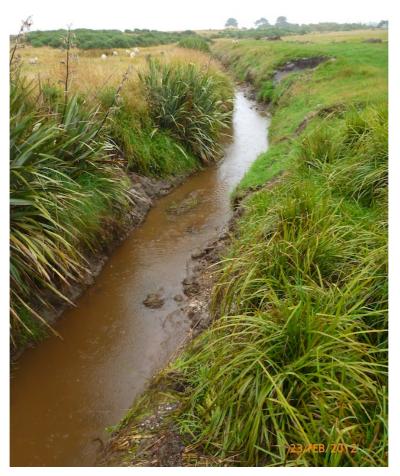
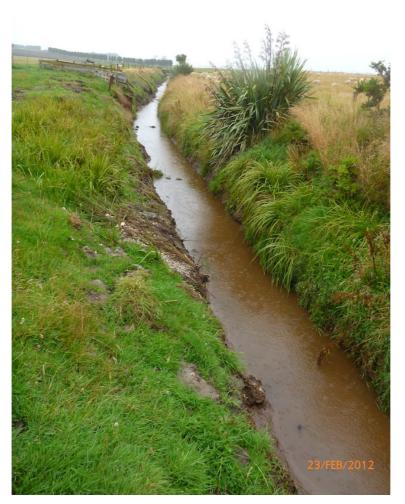
Mahers Tributary was a small channel (>2 m width) that was cleaned prior to the site visit. After cleaning, the channel was relatively uniformly U-shaped with some muddy edges and fine substrate bed and the full channel width was wetted, although overhanging bankside vegetation is likely to provide cover for some fish (*Figure 7*, *Figure 8*).

*Figure* 7 *Mahers Tributary showing a recently cleaned section.*

*Figure 8 Mahers Tributary showing a recently cleaned section.*

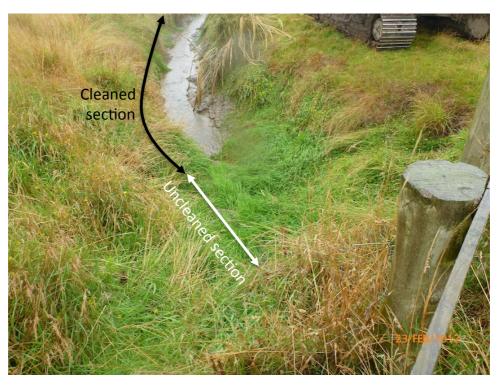
Figure 9

Taylors Tributary was a small drain (>1 m width) that was being cleaned during the site visit. The uncleaned section of channel was extensively infested with grass with no visible surface water (*Figure 9*). After cleaning, the channel was relatively uniformly U-shaped with some muddy edges and fine substrate bed and the full channel width was wetted and water clarity was very low (*Figure* 10). In some areas there was substantial disturbance to the bank (*Figure 11*).

Taylors Tributary showing an uncleaned and cleaned section.

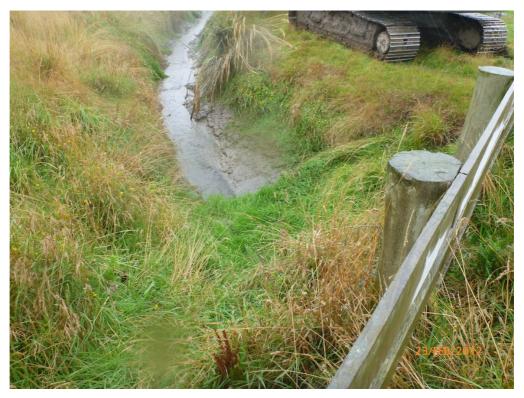
*Figure 10* Taylors Tributary showing the same section as Figure 9 after further cleaning.

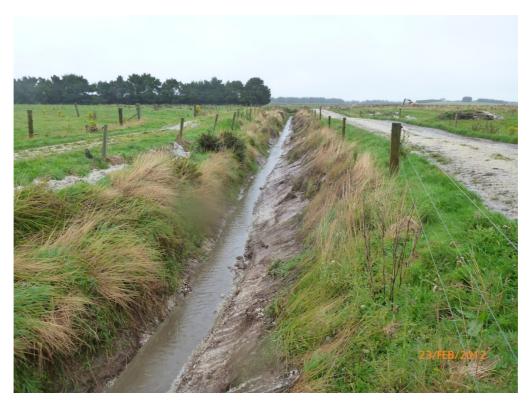
*Figure 11* Taylors Tributary showing a cleaned section of channel with bank disturbance.

It was evident during the visit that banks were disturbed in some areas in Waituna Creek and Taylors Tributary (point b), although the extent of this disturbance was relatively limited. Such disturbance may be unavoidable in some circumstances or may be done to restabilise eroding banks. However there was no evidence of rehabilitation of these areas (point j), although landowners are encouraged to re-sow disturbed areas with grass seed, where practical (J. Chisholm, Environment Southland, *Pers. comm.*).

It was evident during the visit that banks were disturbed in some areas. While such disturbance may be unavoidable in some circumstances, there was no evidence of rehabilitation of these areas having been undertaken. This is recommended to reduce the likelihood of erosion and sedimentation.

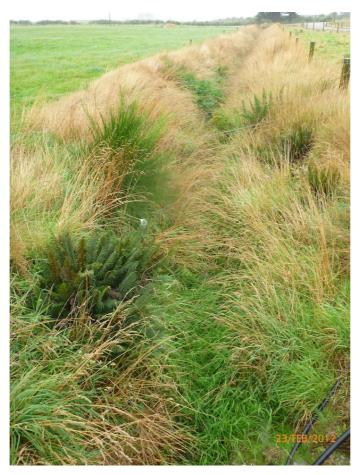
Henderson Tributary is a small channel (>1 m width) that was being cleaned during the site visit. The uncleaned section of channel was extensively infested with grass with no visible surface water (*Figure 12*, *Figure 13*). After cleaning, the channel was relatively uniformly U-shaped with some gravel deposits, muddy edges and gravel or fine substrate bed and the full channel width was wetted and water clarity very low (*Figure 13*, *Figure 14*). It should be noted that the disturbance to the grass on the bank on the same side of the channel as the digger evident in *Figure 13* was caused by the digger driver flattening the grass with the back of the weed rake to give a clear view of the section of channel being cleaned.

*Figure 12 Henderson Tributary showing an uncleaned section of channel, showing lack of open surface water.*

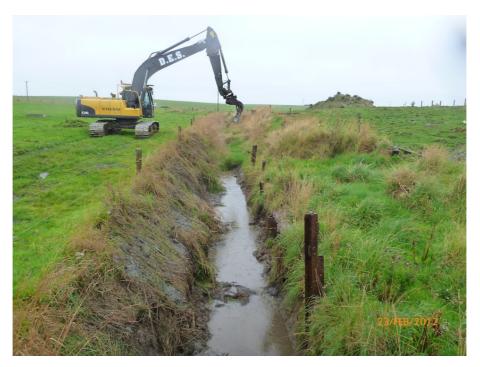
*Figure 13* Henderson Tributary showing a section of channel being cleaned. Cleaned channel in foreground and uncleaned channel beyond digger. Note extensive grass cover in uncleaned section of drain.

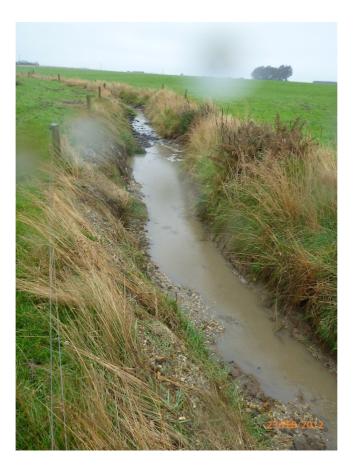
*Figure 14 Henderson Tributary showing a section of channel after being cleaned.*

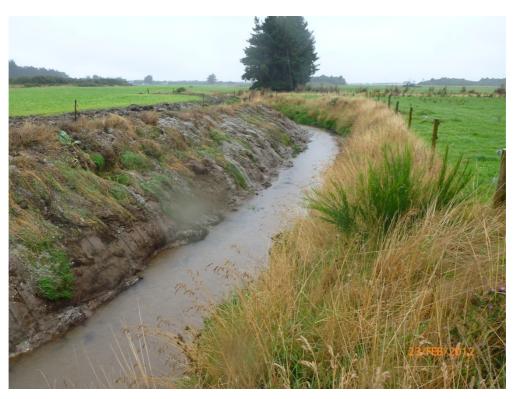
A recently cleaned section of Waituna Creek was viewed near Taylors Tributary (*Figure 15*) as well as an adjoining section that had not been cleaned (*Figure 16*, *Figure 17*).

*Figure 15* Waituna Creek showing a cleaned section with bank damage.

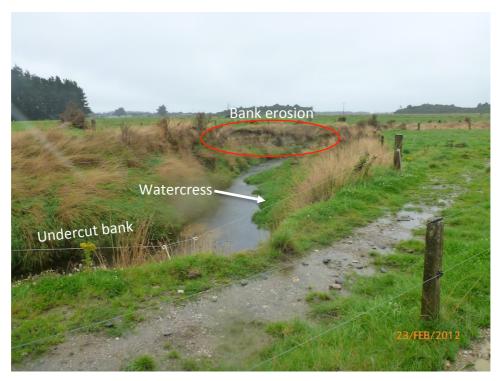
*Figure 16* Waituna Creek showing an uncleaned section with extensive bank erosion.

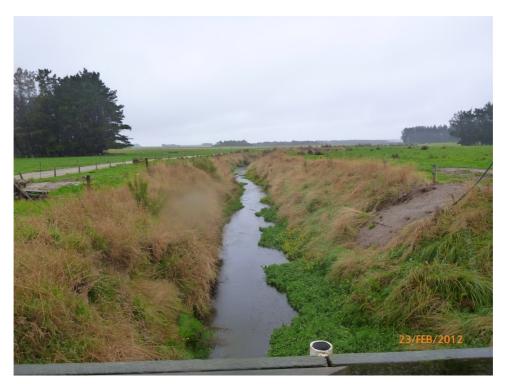
Figure 17 Waituna Creek showing an uncleaned section of channel with bankside cover and watercress.
