# Technical Report on Vegetation Status in Waituna Lagoon: 2009–2025

This report was commissioned by the Department of Conservation (DOC) and based on work under Project DOC20203.

NIWA – National Institute of Water & Atmospheric Research Ltd  
PO Box 11115  
Hamilton 3251  
Phone +64 7 856 7026

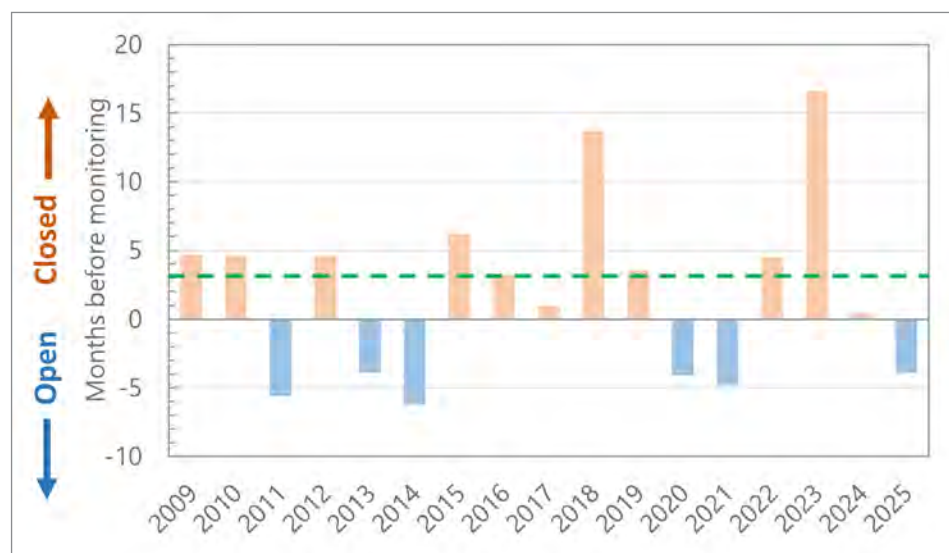
Figure 1: Diverging bar plot showing the number of months for which Waituna Lagoon was open or closed prior to monitoring (as indicated by the y axis). The dotted line indicates the ecological target of three months of lagoon closure before monitoring.

By the time of the annual summer monitoring in January 2025 (20-22 January 2025) the lagoon had been open to the sea for 117 days (Figure 1, Figure 2). Therefore, the target of three months of closed conditions prior to vegetation monitoring (Lagoon Technical Group 2013) was not achieved in 2025 (Figure 1, Figure 2). Nor was it achieved previously in 2024 (Figure 1, Figure 2), although vegetation monitoring in that year was delayed until April by the presence of a toxic algal bloom.

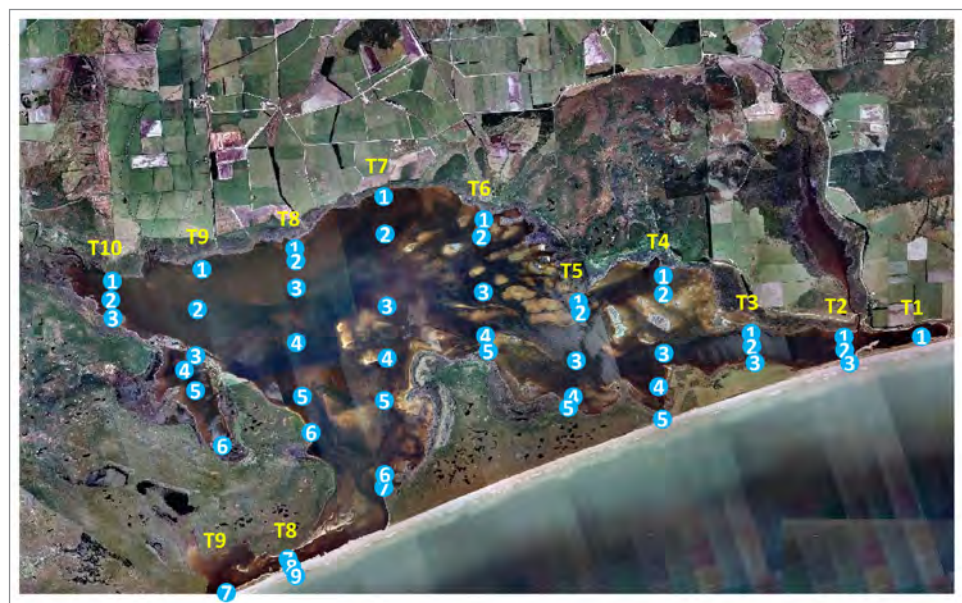
Figure 4: Monitoring sites in Waituna Lagoon. Transects are numbered from 1 to 10 from East to West. The numbers of each transect were allocated on ascending order from North to South. Site T8–9 has been removed due to migration of the coastal barrier.

The location of 47-48 monitoring sites are shown in Figure 4. (One site could not be sampled due to the migration of the coastal spit from 2014 onwards).

The importance of the eastern end of the lagoon as either a refuge for *Ruppia* or a more suitable area for recovery, was apparent again in 2025 as had been noted in previous years. In contrast, 29% of the eastern sites recorded *Ruppia* in 2024, compared to 47% of sites in the west from T6 (Figure 4). The difference between years may have been due to the location of the opening site, which was in the vicinity of Site 2.3 in 2024 when usually the lagoon is opened just west of site 7.7 (Figure 4).
