# Vegetation Status in Waituna Lagoon: Summer 2025

This report was commissioned by The Department of Conservation (DOC) and based on work under Project DOC24203.

This report presents the 2025 annual summer monitoring data for submerged vegetation in Waituna Lagoon in relation to ecological targets that have been identified by the Lagoon Technical Group to guide ecological management. Results are compared to annual monitoring results since 2009. The document is supported by a technical report<sup>1</sup> that describes the water level regime, water quality (physico-chemical) and substrate conditions, submerged vegetation abundance and composition and *Ruppia* life-stage.

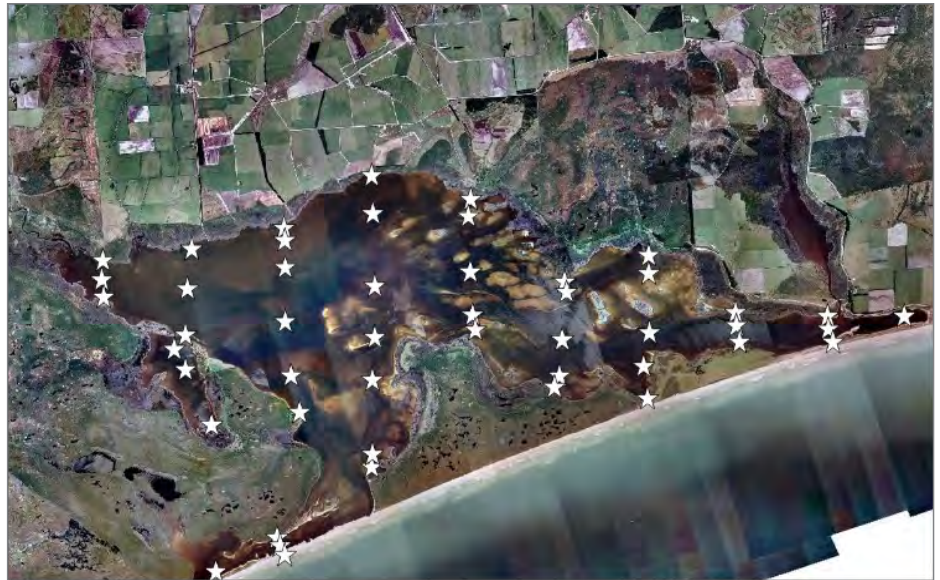
Figure 3a: Map showing the location of sampling sites (47-48).

The lagoon is monitored each year in late summer at 47-48 sites (Figure 3a). At each site, an assessment of environmental quality includes depth and water quality measurements (Figure 3b). Substrate characteristics are measured in four samples of the lagoon bed retrieved using a garden hoe, and the composition and abundance of vegetation is also described, including *Ruppia* life-stage as flowering or vegetative. Submerged native plants and dominant macroalgae are shown in Figure 4.
