Vegetation Status in Waituna Lagoon: Summer 2023

This report was commissioned by The Department of Conservation (DOC) and based on work under Project DOC20203.

This report presents the 2023 annual summer monitoring data for submerged vegetation in Waituna Lagoon in relation to ecological targets that have been identified by the Lagoon Technical Group to guide ecological management. Results are compared to annual monitoring results since 2009.

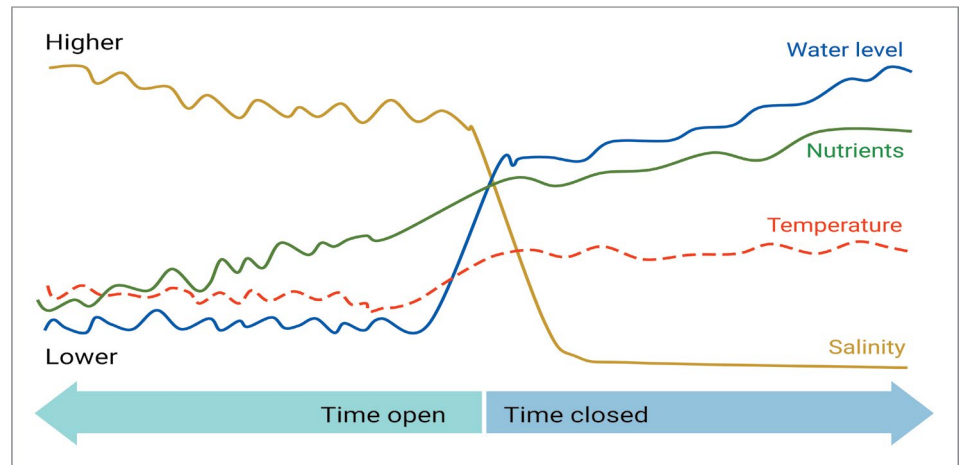
Figure 2: Key changes in the waters of Waituna Lagoon with time after opening or closing to the sea.

Monitoring of the waters of Waituna Lagoon over time⁵ has built up a picture of the key changes caused by opening events⁶. Water level is lower and salinity higher when the lagoon is open and temperature and nutrient concentrations are both reduced with flushing by the sea (Figure 2). These changes and their duration influence the vegetation of Waituna Lagoon.

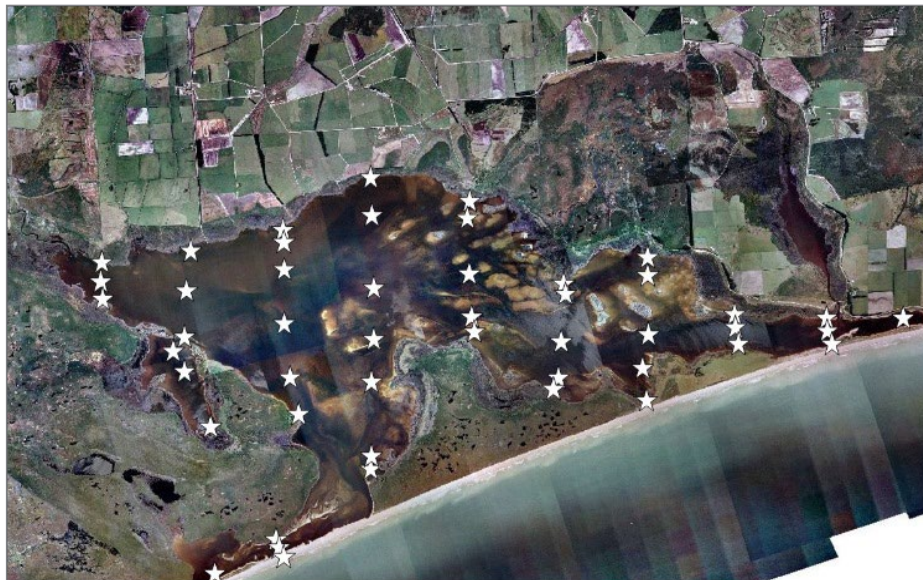
Figure 3a: Map showing the location of sampling sites (47-48).

The lagoon is monitored each year in late summer at 47-48 sites (Figure 3a). At each site, an assessment of environmental quality includes depth and water quality measurements (Figure 3b). Substrate characteristics are measured in four samples of the lagoon bed retrieved using a garden hoe, and the composition and abundance of vegetation is also described, including *Ruppia* life-stage as flowering or vegetative. Submerged native plants and dominant macroalgae are shown in Figure 4.

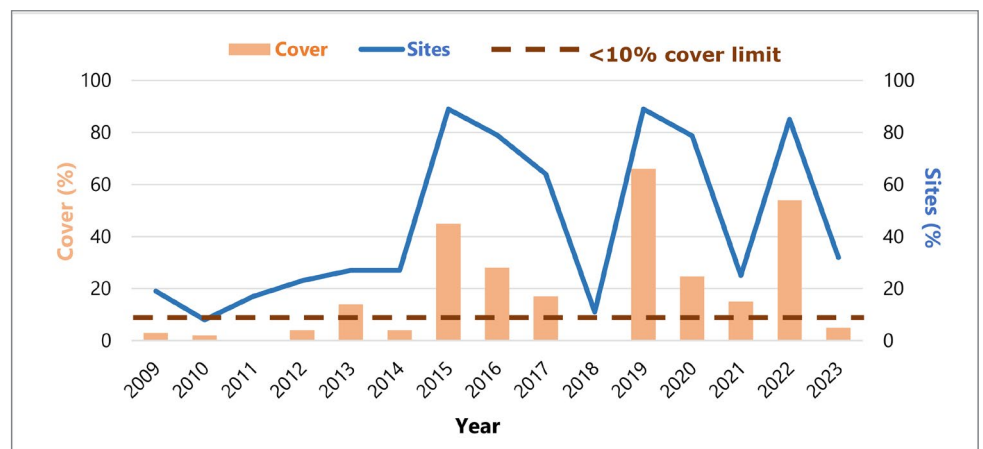
Figure 6: Lagoon-wide cover of macroalgae is shown as orange bars and percentage of sites at which macroalgae was present as a blue line.

Lagoon-wide average macroalgae cover in 2023 met the target, being <10% (Table 4, Figure 6). This result contrasts with seven out of the previous eight years (2015 to 2022) that had relatively high macroalgae abundance (Table 4, Figure 6). Macroalgal cover (Table 4, Figure 6) has not reflected whether the lagoon closure target was met or not (Table 1).
