WAITUNA

Partners' News

This is the third annual newsletter and provides updates from each of the Partners as well as details on several of the key projects completed or underway in the catchment.

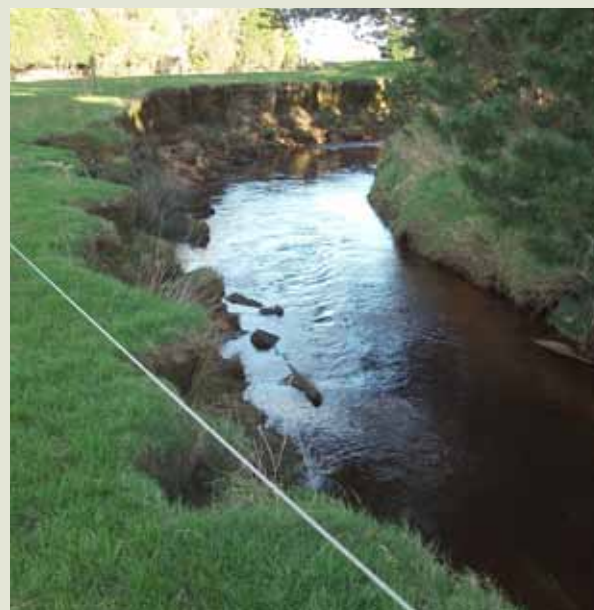
Before work started on bank reconstruction along the Waituna Creek.

Environment Southland has begun a Waituna Creek Riparian Planting Initiative – looking to plant 14km of reconstructed banks along the Waituna Creek.

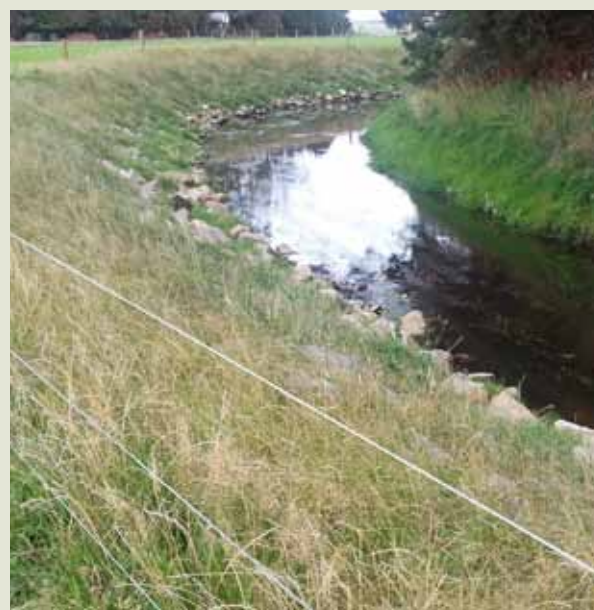
After the completion of reconstruction work.

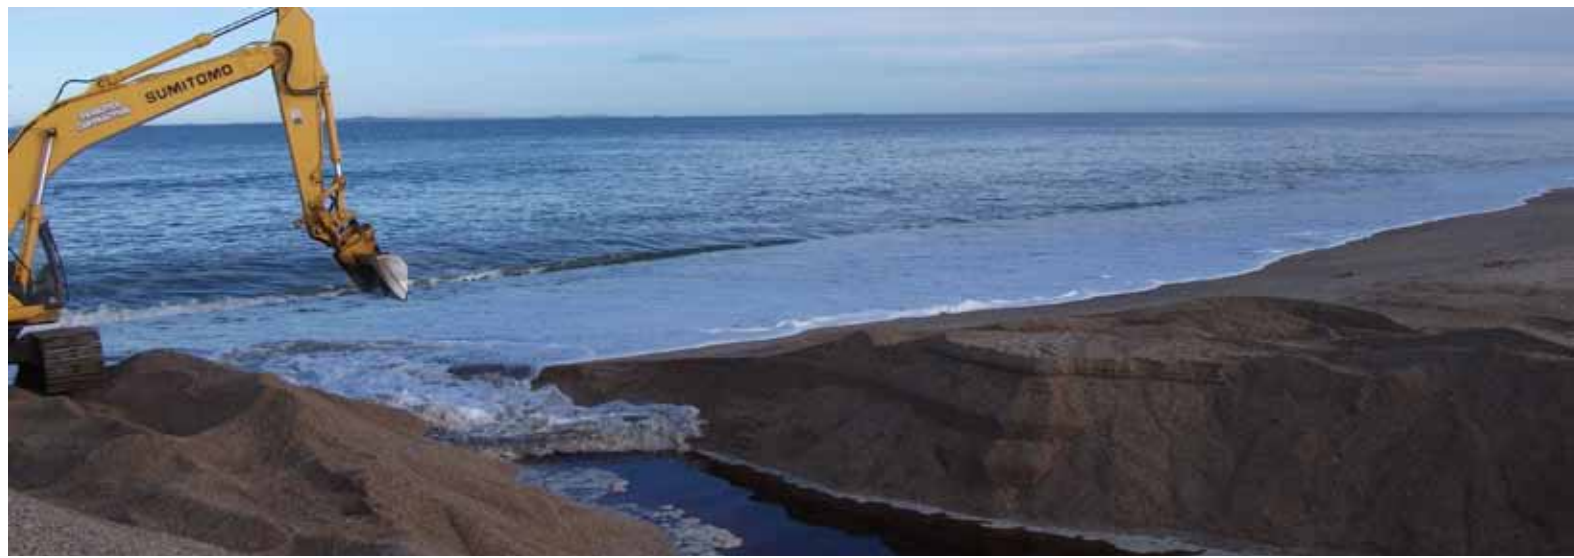
Opening Waituna Lagoon to the sea.

The lagoon was opened on 10 September 2015 (closed 10 October 2015) and reopened on 3 June 2016 (and remains open).

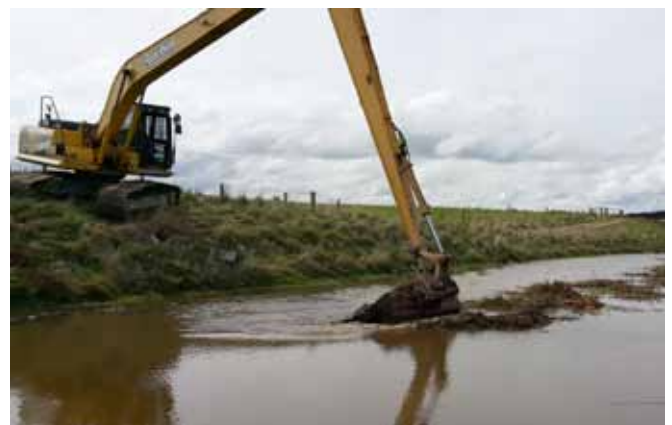
Eleocharis is transplanted to a constructed wetland trial area.

Early in October Environment Southland staff were out working in Waituna to transplant some established eleocharis from a local farmer's pond to the constructed wetland trial further up the catchment.

The digger was amazingly gentle, managing to put the large clumps of these aquatic plants into the wetland intact. They'll be great for taking up excess nutrients in the water. Here's hoping the pukeko will leave these ones alone.

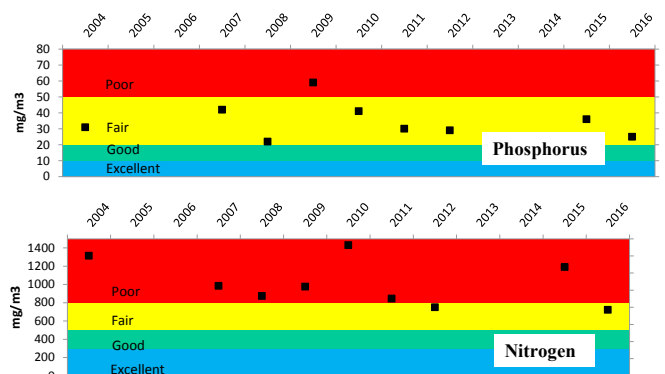
The two charts below show the water quality in the Waituna Lagoon with each dot representing the **median** (the middle number for all the samples) nutrient concentration for closed periods (varying from 5 to 30 months) for phosphorus and nitrogen.

The colourful bars represent the different conditions as outlined by the national standards. Excellent represents a healthy and resilient system that is similar to natural reference conditions, and poor represents a degraded state at high risk of shifting to an algae dominated system.

Combined, these figures illustrate that during closed periods Waituna Lagoon experiences high stress levels, well above natural reference conditions.

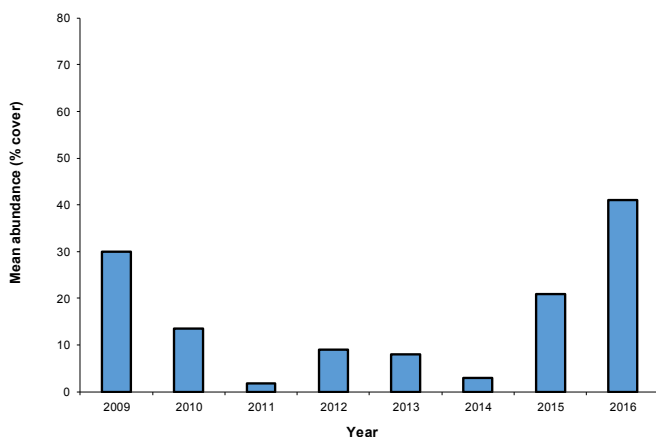
Average cover for ruppia (*R. megacarpa* and *R. polycarpa* combined) across Waituna Lagoon (all sampling sites).

When the lagoon is open, nutrients and sediments can be flushed out. It is a fine balance between closed periods that have elevated nutrient concentrations and open periods with increased saltwater that affect the lifecycle of ruppia. For example, an opening in 2013/2014 lasted for 380 days and negatively impacted on the ruppia cover. When the lagoon was only open for two periods of 15 and 30 days over winter and spring in 2015, ruppia cover rebounded to healthier levels.

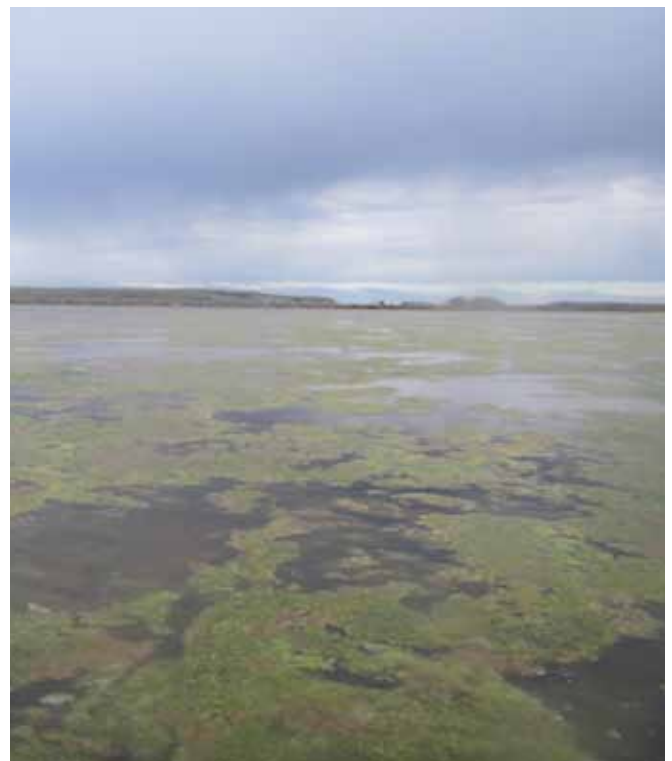
At the end of October/ beginning of November an extensive green algal bloom was seen at the eastern end of Waituna Lagoon. (Photo Chris Owen)

It also means that the lagoon is more likely to exhibit signs of stress in response to abnormal environmental conditions. For example the lack of wind, warmer temperatures and the localised delivery of nutrients by Waituna Creek is thought to have caused the algal bloom at the eastern end of the lagoon that occurred at the end of October this year. This particular algae is one that grows on other plants/algae and can shade them out.

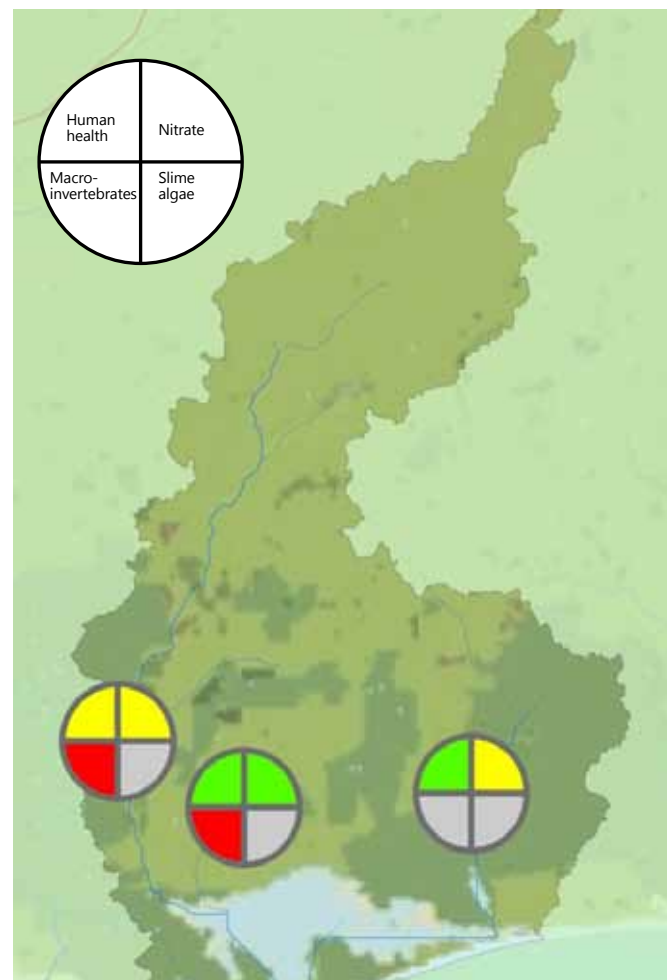
Results show there is an increased health risk on Waituna Creek.

The yellow results indicate nitrate levels on Waituna and Carran Creeks can have an impact on the 5% most sensitive species.

Currently we don't have enough data on slime algae for Waituna to make an assessment, so this quadrant is grey.

The median MCI scores over 2010–2014 are compared to national guidelines for sites with more than three observations. Monitoring locations with red in the bottom left quarter do not meet the national guidelines for macroinvertebrates (note: macroinvertebrates are not monitored on Carran Creek, hence the grey quadrant).
