REPORT NO. 3023

**METHODS FOR WAITUNA CREEK FISH AND
HABITAT MONITORING IN ASSOCIATION WITH
BANK RECONSTRUCTION AND POTENTIAL
HABITAT REHABILITATION (2017)**

Department of Conservation, Southland

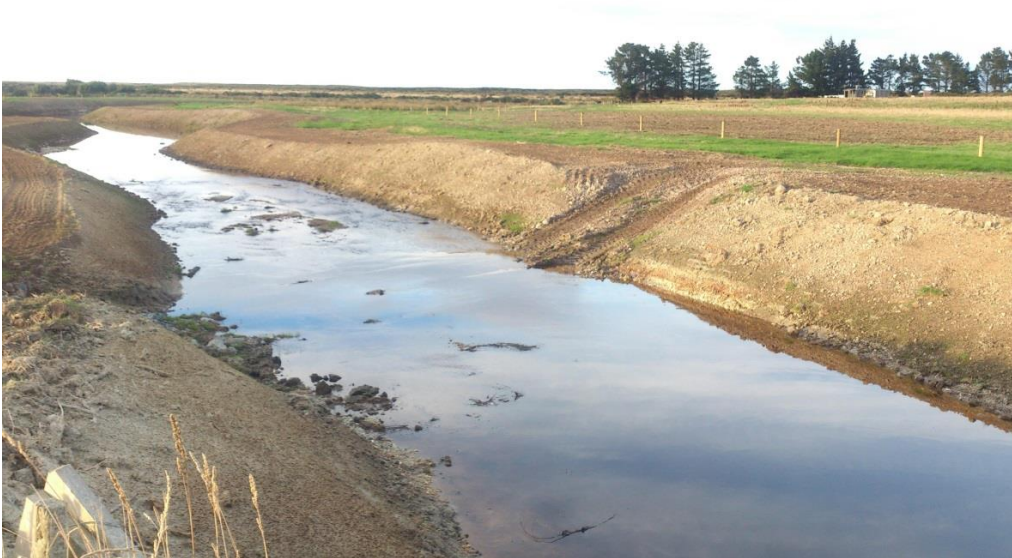
Figure 1. Bank re-shaping in a reach of the lower Waituna Creek (March 2014)

Fine sediment loading from eroding banks in the intensively-farmed Waituna Creek catchment is threatening biodiversity values in the downstream Waituna Lagoon (Robertson et al. 2011). In order to reduce the amount of stream-bank derived sediments (and associated contaminants) entering Waituna Lagoon, Environment Southland (ES) have undertaken extensive bank reconstruction works (bank reshaping) in Waituna Creek. The bank reshaping involved scraping the stream banks from the water's edge to a 1 in 2 slope along approximately 10 kilometres of stream throughout the mid-lower catchment (Figure 1). The work was initiated during January 2014 and was completed in summer 2016.

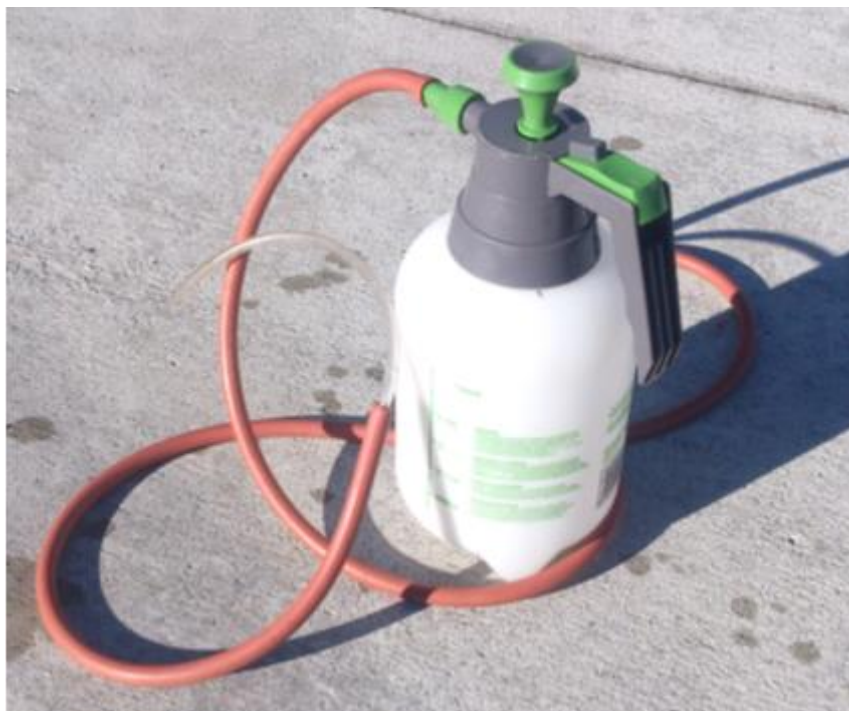
During the 2017 electric fishing survey, trout gut content samples were collected using a gastric lavage pump (Figure 3). The pump was constructed using a 2-litre garden spray hand pump and a metre of flexible hose. A 200 mm length of semi-ridged plastic tubing (5 mm diameter) was attached to the end of the hose. This was inserted down a trout's oesophagus whilst holding the trout ventral side up. Stomach contents were flushed into a white tray and the entire sample was then transferred to a pottle(s) and preserved with 70% ethanol. For small fish (< 200 mm), a 3 ml plastic Pasteur pipette was attached to the end of the plastic tubing.

Figure 3. Trout gastric lavage pump.
