Macrophyte monitoring of Waituna Lagoon 2011

Prepared for Department of Conservation
Southland Conservancy

NIWA Client Report No: HAM2011-054
Report date: June 2011
NIWA Project: DOC11205

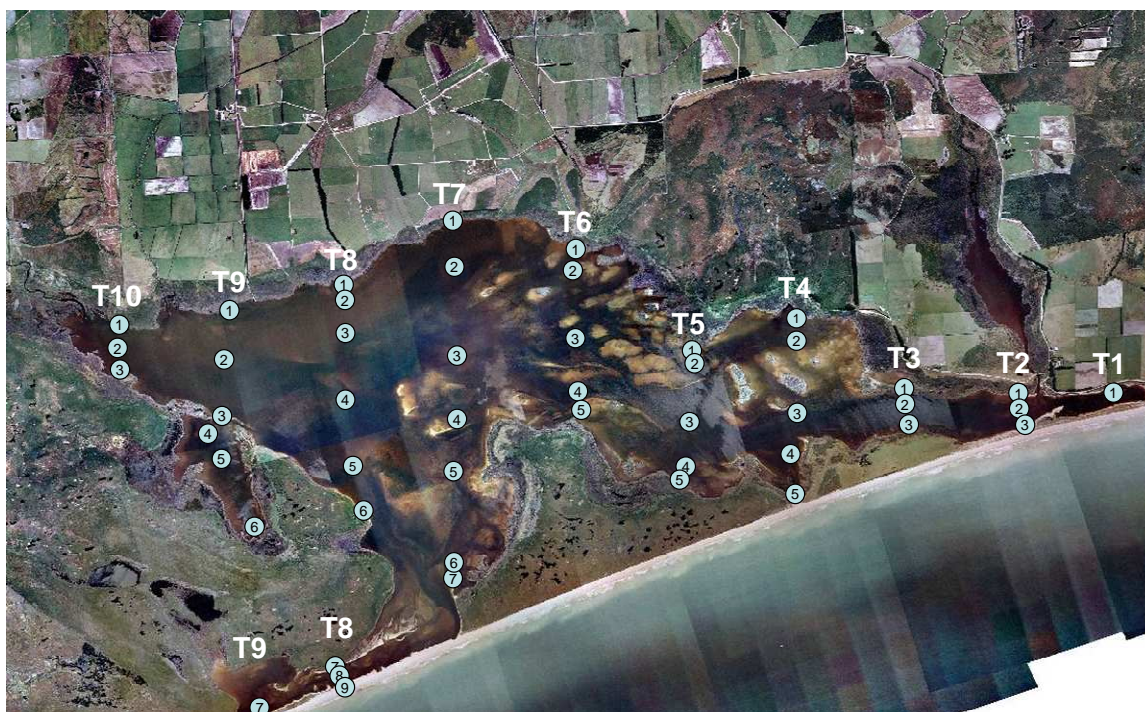
Figure 1: Geo-referenced survey sites in Waituna Lagoon. Transects are numbered 1 to 10 East to West and numbered on each transect in ascending order from north.

Forty-eight sites were re-surveyed in Waituna Lagoon (Figure 1) situated on 10 transects across the lagoon as established by Robertson and Stevens (2009). Sites were positioned near the edge of the lagoon to sample shallow water habitats and mid-lagoon to sample deeper water habitats. On longer transects, additional sites were included for spatial coverage (Robertson and Stevens 2009). Sites were re-located using GPS co-ordinates provided by DoC.

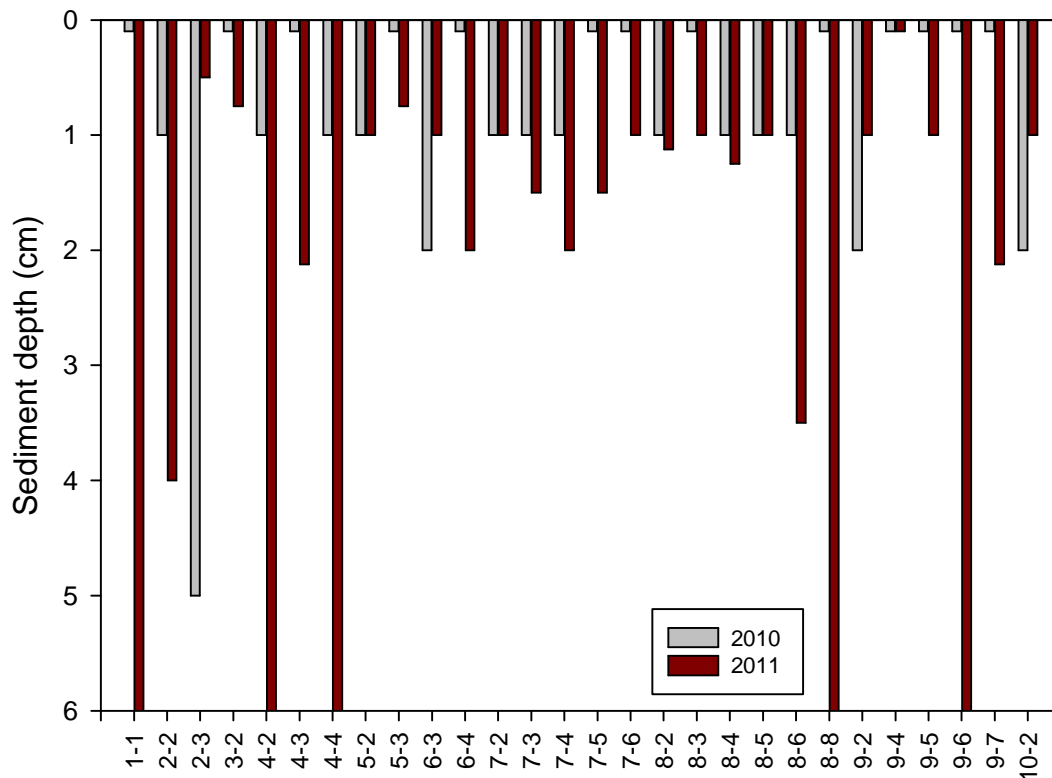
Depth to blackened 'sulphide' layer at submerged sites varied across the lagoon ranging from just below surface to absent in the surface 6 cm (Figure 5). Compared to 2010, there has been an improvement in the depth to blackened layer at 19 sites (i.e., positioned at greater sediment depth), while only 4 sites had shallower layers relative to 2010 (Figure 5).

Figure 5: Depth (cm) to the blackened 'sulphide' layer at submerged sites in 2011 compared to depths recorded in the 2010 survey (Stevens and Robertson 2010). Note sites that were dry during the 2011 survey have been excluded from this graph for ease of viewing regardless if there were measurements taken during the 2010 survey.

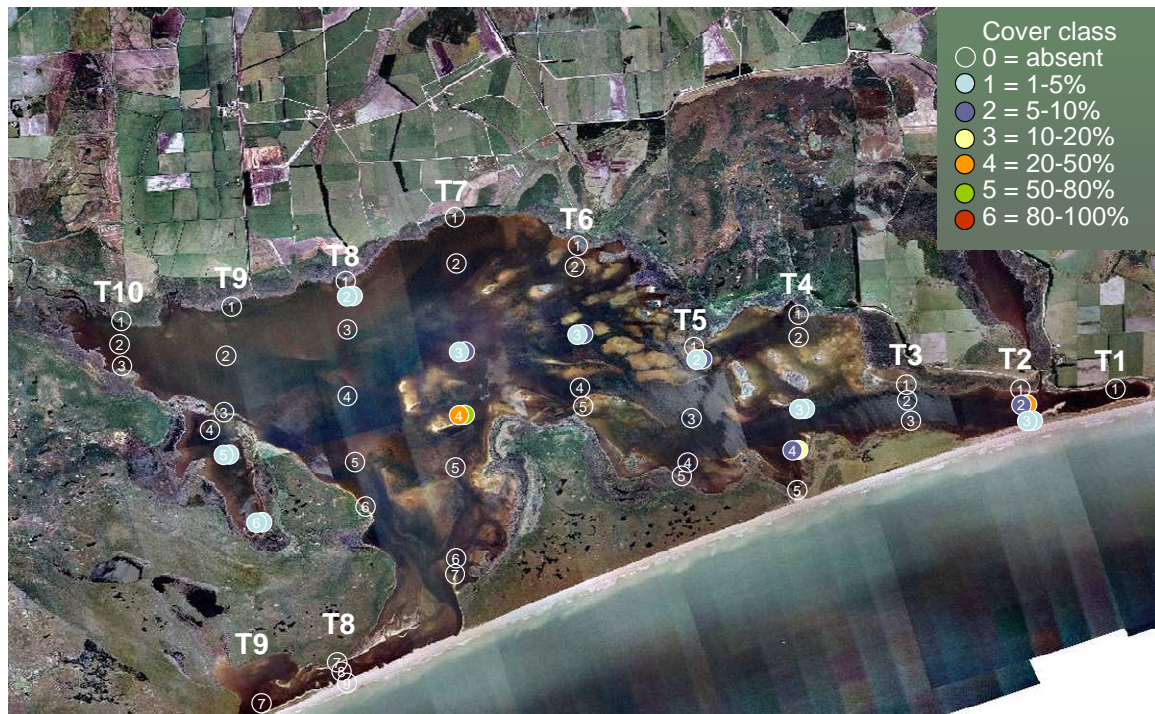
Both *Ruppia megacarpa* and *R. polycarpa* were present in Waituna Lagoon, recorded from eleven sites overall (Figure 6). Cover of *Ruppia* spp. was low with most vegetated sites having an average cover of 1-5% (Figure 6). *R. megacarpa* and the marine macroalgae *Ulva intestinales* were the most frequently occurring species, both occurring at 6 sites. *Gracilaria chilensis*, also a marine macroalgae, was present at one site. No other macrophyte was present in the lagoon at the time of survey, however, fragments of *Myriophyllum triphyllum* and *Potamogeton ochreatus* were arriving from freshwater stream inputs.

Mean height (4 replicates) of ruppia beds at each site ranged from 2 to 12 cm across the lagoon and all plants were in vegetative state (no flowering or fruiting evident).

Figure 6: Cover of *Ruppia* spp. at survey sites (Figure 1) in Waituna Lagoon during the 2011 survey. Cover shown as average (foreground) and maximum (background) according to the cover categories of Robertson and Stevens (2009).

To overcome these limitations and identify better indicators that will assist DoC with managing the lagoon, we suggest increasing both the temporal and spatial scale of the macrophyte surveys. This need not necessarily involve more cost as the current methodology is very intense on the fine scale.
