Vegetation Status in Waituna Lagoon: Summer 2018

This report was commissioned by The Department of Conservation (DOC) and based on work under Project DOC18202.

This report assesses the 2018 annual summer monitoring data for submerged vegetation in Waituna Lagoon in relation to ecological targets that have been identified by the Lagoon Technical Group to guide ecological management. Results are compared to annual monitoring results since 2009.

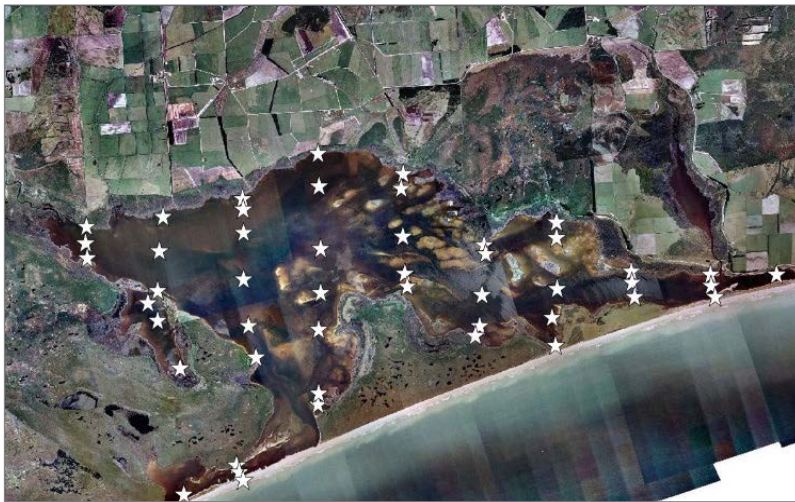
Figure 2: Map showing the location of sampling sites (47-48) and diagram on right showing the sampling design.

The lagoon is monitored each year in late summer at 47-48 sites. At each site an assessment of environmental quality includes depth and water quality measurements (Figure 2). Substrate characteristics are measured in four samples of the lagoon bed retrieved using a garden hoe, and the composition and abundance of vegetation is also described, including *Ruppia* life-stage as flowering or vegetative (Figure 2). Submerged native plants can usually be identified directly (Figure 3), but the dominant macroalgae may only be described to type (Figure 3) based on appearance and samples.

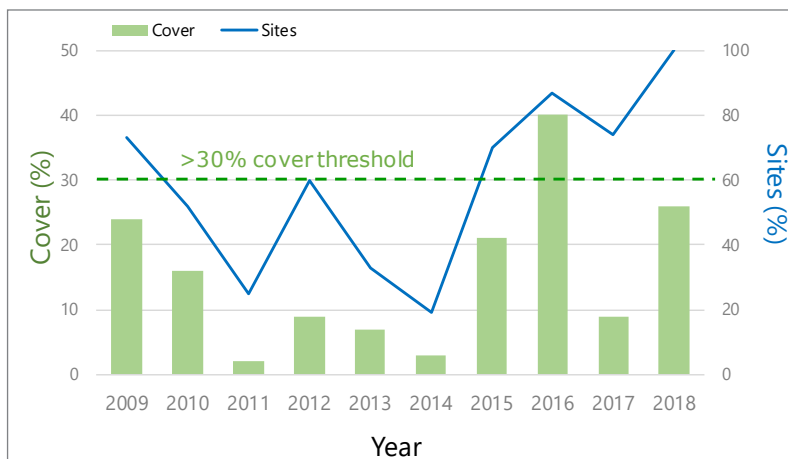
Figure 4: Lagoon-wide cover of *Ruppia* is shown as green bars and percentage of sites at which *Ruppia* was present as a blue line.

A healthy *Ruppia* community occupies a large habitat area in Waituna Lagoon. This is measured by calculating the percentage cover of *Ruppia* across all sites in the Lagoon. In 2018, although *Ruppia* was recorded at all sites (Table 2, Figure 4), the lagoon-wide average percentage cover did not meet the ecological target of >30–60% (Box 1).
