Vegetation Status in Waituna Lagoon: Summer 2019

This report was commissioned by The Department of Conservation (DOC) and based on work under Project DOC18202.

DOC commissioned NIWA to undertake the 2019 summer-time Waituna Lagoon survey to document the health of submerged vegetation and to provide an inter-annual comparison of its condition. This report summarises the key findings to guide further ecological management of the lagoon.

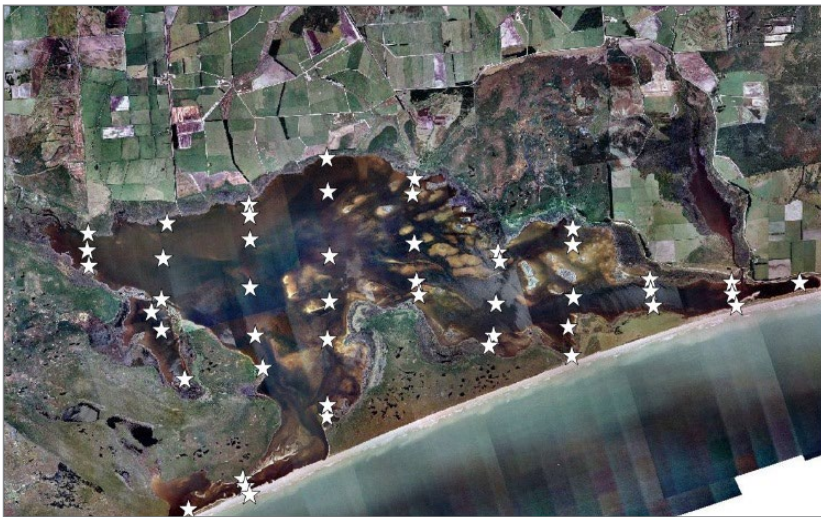
Figure 2a: Map showing the location of sampling sites (47-48).

The lagoon is monitored each year in late summer at 47-48 sites (Figure 2a). At each site an assessment of environmental quality includes depth and water quality measurements (Figure 2b). Substrate characteristics are measured in four samples of the lagoon bed retrieved using a garden hoe, and the composition and abundance of vegetation is also described, including *Ruppia* life-stage as flowering or vegetative. Submerged native plants can usually be identified directly (Figure 3), but the dominant macroalgae may only be described to type (Figure 3) based on appearance and samples.
