Technical Report on Vegetation Status in Waituna Lagoon: 2009–2020

This report was commissioned by The Department of Conservation (DOC) and based on work under Project DOC20203.

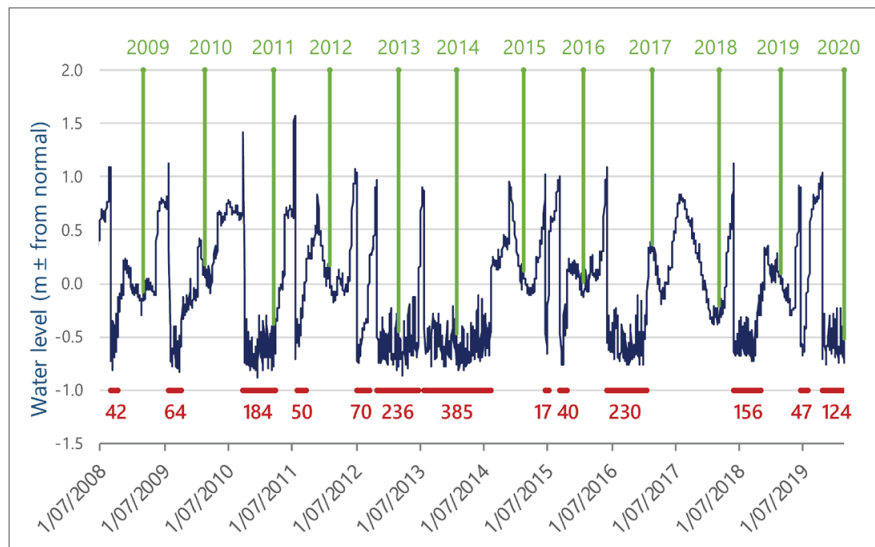
Figure 2: Plot showing the continuous water level time series for Waituna Lagoon, measured at Waghorns Road. Periods of lagoon opening are indicated by horizontal red lines. The number of days during which the lagoon was open correspond to the red numbers. Finally, the annual summer vegetation monitoring events are indicated by green vertical lines.

Over winter 2019, two lagoon openings were made. The initial opening in mid-June lasted 47 days before closing, but rapidly rising water level necessitated a second opening in mid-October 2019 which then persisted (Figure 2). As previously, tidal exchanges and sea level following lagoon opening resulted in oscillations in water level around a lagoon height that was approximately 0.5 m less than normal level (Figure 2).

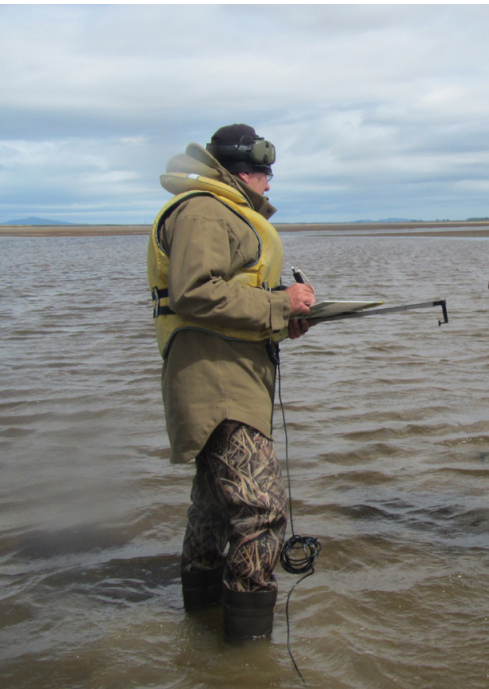
Figure 4: Monitoring sites in Waituna Lagoon. Transects are numbered from 1 to 10 from East to West. The numbers of each transect were allocated on ascending order from North to South.

The location of 47-48 monitoring sites is given in Figure 4. (One site could not be sampled due to the migration of the coastal spit from 2014 onwards).

At each monitoring site (Figure 4), four replicate samples 15 x 15 cm and 6 cm deep were cut from the lake-bed, using a flat based garden hoe, and carefully lifted to the surface.

At each site (Figure 4), four replicate samples 15 x 15 cm and 6 cm deep were cut from the sediment, using a flat based garden hoe, and carefully lifted to the surface. Each sample was assessed for:

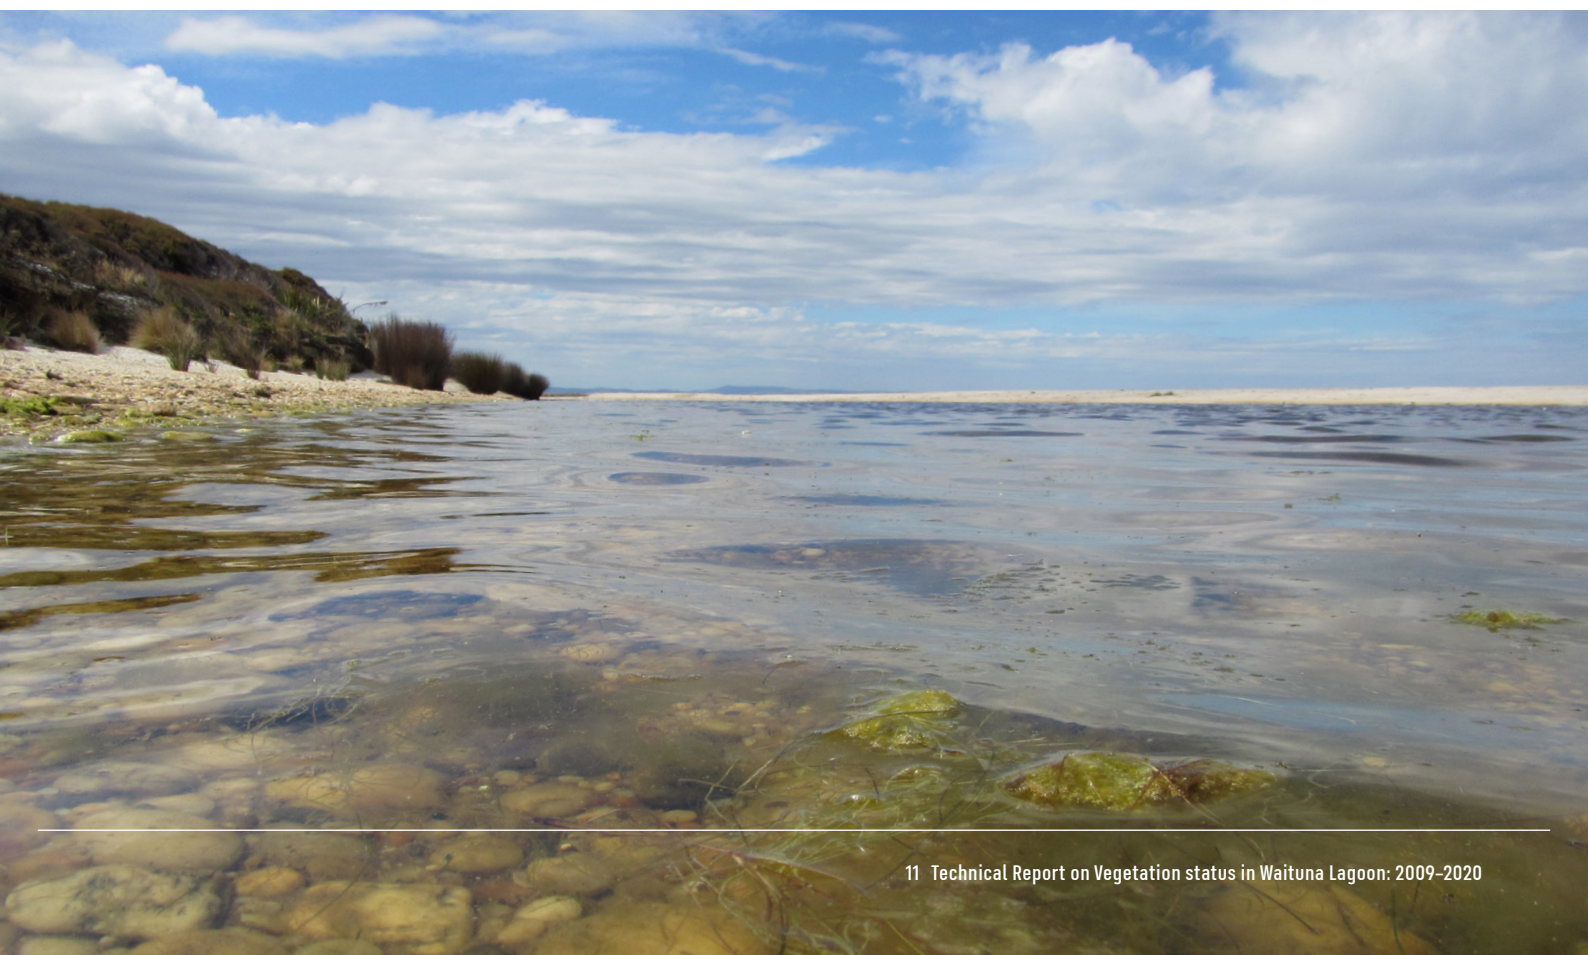
Figure 5: Box and whisker plots of salinity (top), depth (middle) and temperature (bottom) over all monitoring years. (n= 48 or 47).

At the time of the 2020 monitoring, Waituna Lagoon had been open to the sea for 4.1 months. Salinity levels were high (average 25.2 PSU), similar to levels recorded in 2011 and 2014 (Figure 5) when the lagoon had been open for over five months. Salinity was also higher in 2017 (average 10.3 PSU), when the lagoon had only been closed for a month before monitoring. Highest salinity levels in 2020 (≥ 30 PSU) were recorded at the ten closest sites to the barrier opening.

Although monitoring sites tended to be shallow in 2020 (average 0.52 m), water depth was slightly deeper than was recorded during other monitoring events when the lagoon was open to the sea in 2011, 2013 and 2014 (Figure 5). This may be related to the tidal cycles during the respective monitoring. Four sites that were dry during 2020 monitoring had been recently inundated. Relatively shallow depths recorded during monitoring in 2018 (Figure 5), despite the lagoon being closed, were due to drought conditions in Southland. The remainder of monitoring events were deeper under closed lagoon conditions (Figure 5).

Water temperature in 2020 (average 18.6°C) was amongst the four highest recorded years (including 2013, 2015 and 2017) (Figure 5). Water temperatures have been noticeably higher since 2012.

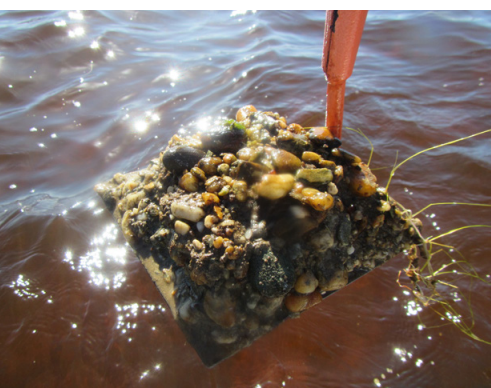
Figure 7: Bar plot illustrating the composition in substrate type (% occurrence), recorded during each of the annual monitoring surveys. Substrate types are numbered from softer to harder.

In 2020, sampled sites had a smaller proportion of the softer substrates (categories 1–3) than sampling in 2019 (Figure 7). Similar levels of soft substrate to 2020 were recorded in 2012–2014, 2016 and 2018. By contrast, harder substrates in 2020 (categories 7 to 10, Figure 7) were also reduced relative to 2019, and more similar to 2009–2012 and 2018. Therefore, most sites were characterised in the mid-range of sediment hardness (categories 4–6) in 2020 (Figure 7).

The reduction in soft substrates in 2020, together with increases in the proportion of substrates in the mid-range for hardness, suggests some re-distribution of substrates by tidal currents generated under the open lagoon status. Harder substrates are associated with a better ecological condition (Stevens and Robertson 2007).

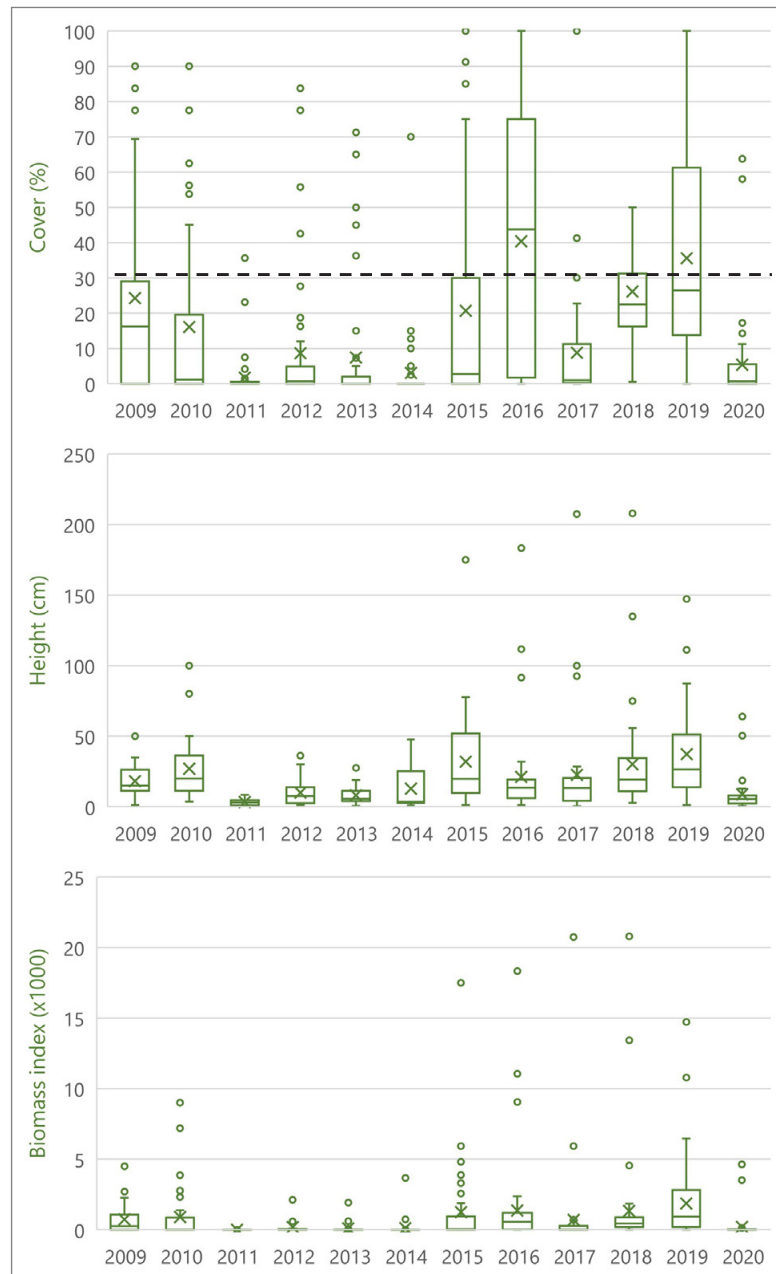
Figure 10: Box and whisker plots of *Ruppia* cover (top), height (middle) and derived biomass index (bottom) over monitoring years. Average of measurements at monitoring sites (n= 48 or 47). Dotted line represents the lagoon-wide target for *Ruppia* cover of 30% identified by the Lagoon Technical Group (2013).

The cover of *Ruppia* measured by the hoe method in 2020 averaged 5.4%. This cover value represented a large decrease from 2019 and was similar to low covers (<10%) measured in 2011–2014 and 2017 (Figure 10). High *Ruppia* covers ($\geq 80\%$) were recorded in hoe samples at two sites in 2020 that were dominated by *R. megacarpa*. Similarly, 58% of hoe samples that recorded high covers ($\geq 80\%$) over all surveys comprised *R. megacarpa*, which was disproportionate to the species occurrence. The height of *Ruppia* in 2020 (average 8.8 cm) was also reduced relative to 2019 (Figure 10) and was similar to levels recorded in 2011 and 2013 (≤ 10 cm). The two upper outlier sites for height measured in 2020 comprised *R. megacarpa*. *R. megacarpa* has also comprised 61% of all height records ≥ 50 cm that have been measured to date through all monitoring years.

‘Biomass index’ is calculated as the product of average cover times height at sites using the hoe method and is a proxy for biomass in *Ruppia*. Biomass index averaged 199 in 2020, which was similar to 2012–2014 but higher than 2011 (Figure 10). In contrast, average

biomass index exceeded 1000 in 2015, 2016, 2018 and 2019 (Figure 10). As common in years before, high outliers for biomass index in 2020 represent sites with *R. megacarpa*.

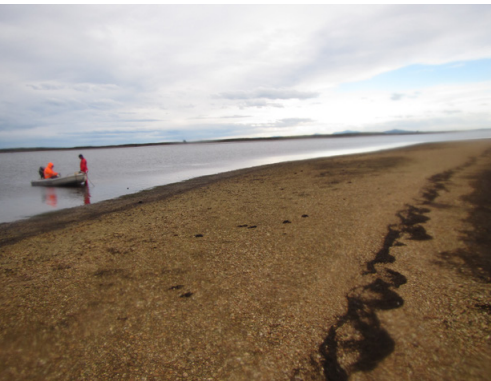
Figure 11: Relationship between *Ruppia* cover (top) and height (bottom) estimated from hoe samples and diver observations within a 10 m diameter area at each site.

Macrophyte observations by divers at sites (all years since 2013) have correlated with the results obtained from the hoe method (Figure 11). Observations tended to give higher average covers than the hoe method, particularly where hoe covers were low (Figure 11). This may reflect the patchy nature of *Ruppia* clumps. However, in 2020, the average lagoon-wide cover of 5.7% for *Ruppia* using the diver observations was very similar to the lagoon-wide estimate of 5.4% cover using the hoe method. Diver observations similarly showed low average *Ruppia* covers of less than 12% for monitoring years 2013, 2014 and 2017 with covers exceeding 30% for the years 2015, 2016, 2018 and 2019. Average height of *Ruppia* in 2020 from diver observations was 17.5 cm, higher than those based on hoe samples (Figure 11), but this result likely reflects the greater chance of encountering tall plants in the wider assessed area.

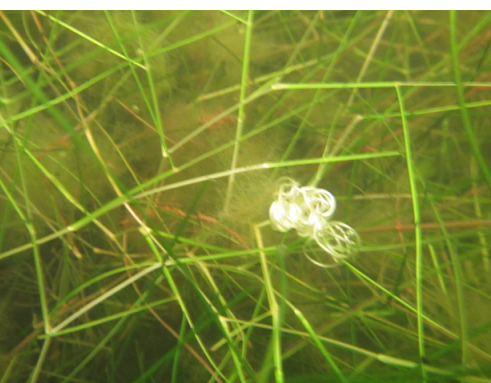
Figure 12: Life-stage category of *Ruppia* species across monitoring years as a proportion of records.

Reproductive status of *Ruppia* in 2020 was amongst the lowest recorded (Figure 12). Just 6% of observations were for flowering or post flowering samples from the hoe method, similar to 2011, 2013, 2014 and 2017 (Figure 12) when the lagoon had also been open for most of the *Ruppia* spring-summer growth period.

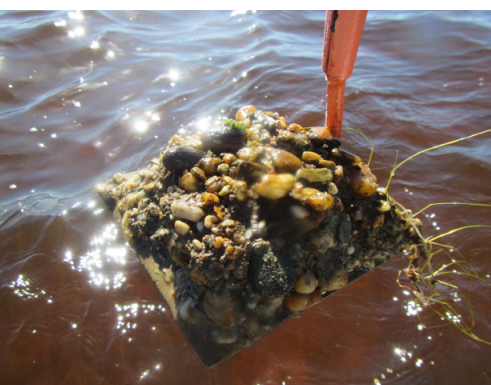
Figure 14: Relationship between macro-algal percentage cover estimated from hoe samples and diver observations within a 10 m diameter area at each site.

There remains a weak correlation (all monitoring years) between macroalgal cover estimate by hoe samples and overall covers observed by divers (Figure 14). It appears that macroalgal covers are likely to be under-estimated by the hoe method, as was reported in 2009 and 2010 (Robertson and Stevens 2009, Stevens and Robertson 2010). Also, macroalgae can occur as benthic, epiphytic and floating growths, which poses problems for the hoe method that constitutes benthic sampling.
