Technical Report on Vegetation Status in Waituna Lagoon: 2009–2023

This report was commissioned by the Department of Conservation (DOC) and based on work under Project DOC20203.

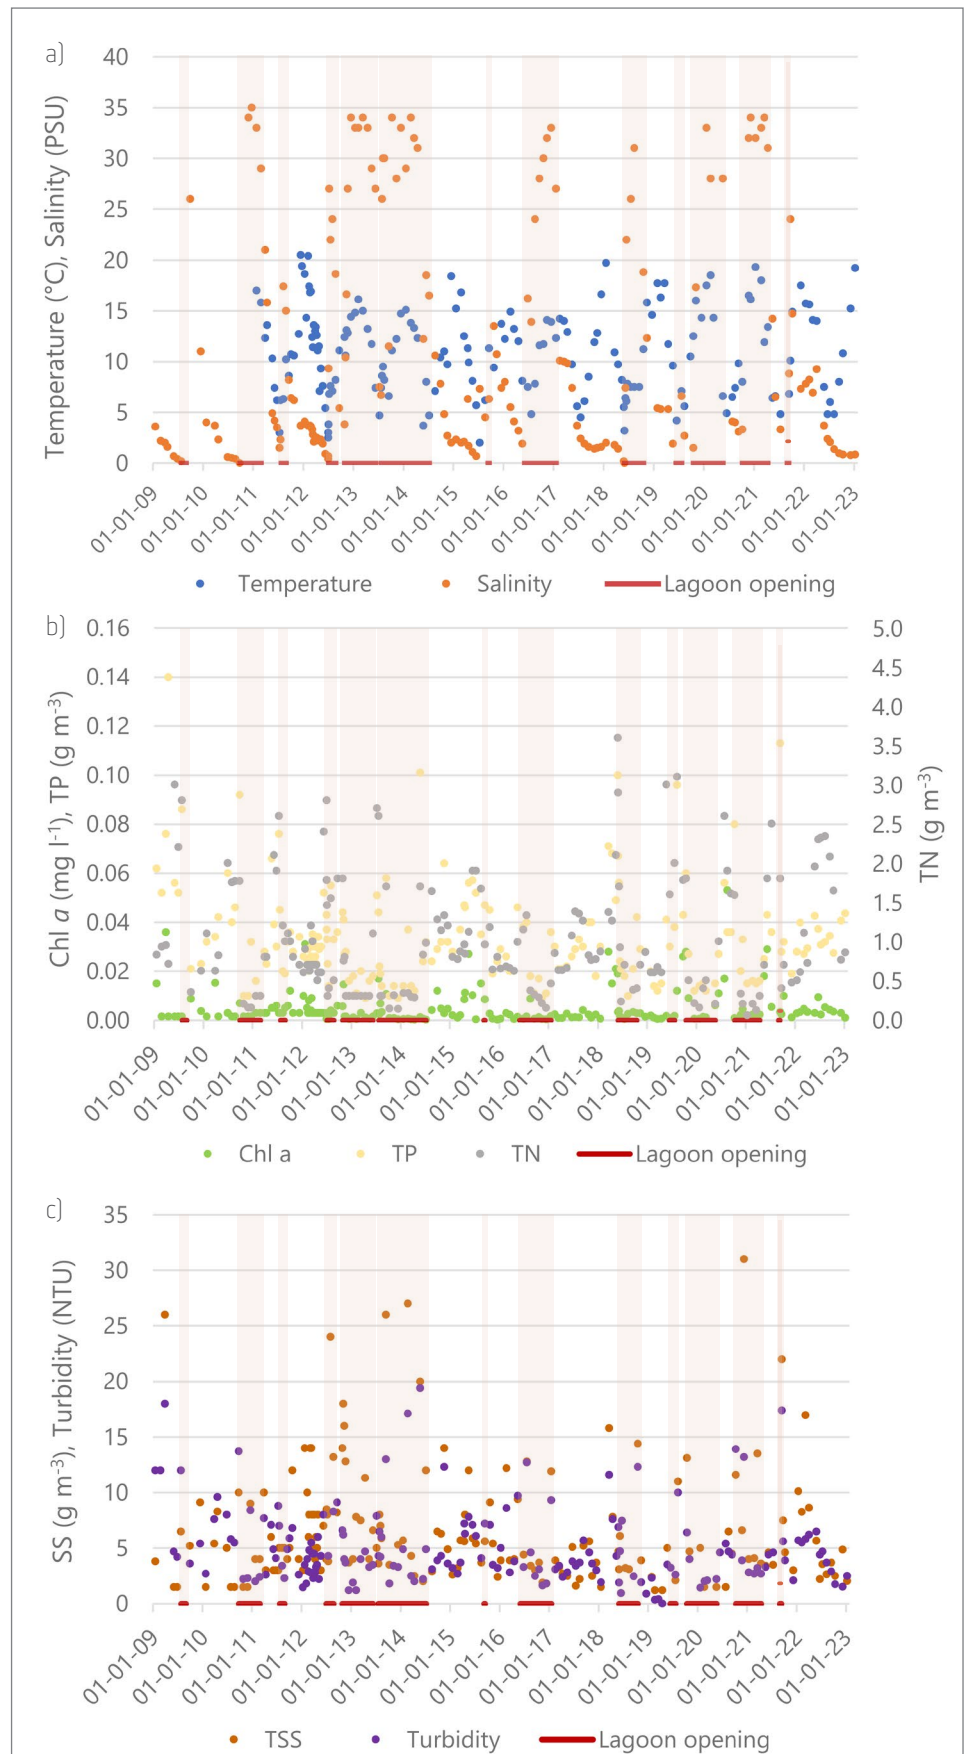
Figure 3: a) Timeseries of temperature and salinity, b) Chlorophyll-*a* (Chl-*a*), total phosphorus (TP), and total nitrogen (TN), and c) Total suspended solids (TSS) and turbidity at the lagoon centre sampled over 2009 to 2023.

Salinity levels in Waituna Lagoon are generally related to the opening regime. Salinity showed a steady drop over the nine months prior to the 2023 vegetation monitoring (late January), to a value of 0.9 PSU in early January (Figure 3a). Similar salinity declines are seen for extended closed periods, while after opening events salinity could approach the value of seawater (Figure 3a).

Water temperature increased by almost 15°C between August 2022 and early January 2023, to a value of 19.2°C prior to vegetation monitoring. Water temperature maxima prior to the 2023 monitoring were similar to 2018 to 2022 (>15°C), but warmer than temperature between 2016 to 2017 and 2013 to 2014, according to the Environment Southland data (Figure 3a).

In the 12 months before the vegetation monitoring in late January 2023, Chl-*a* concentration was low (<0.01 mg l⁻¹) without some of the higher peaks (>0.2 mg l⁻¹) seen in 2009, 2012, 2015 and 2018 to 2021. Although TN levels over the last year showed similar patterns to previous years with winter peaks, TP concentrations were constrained to a lower range of <0.05 g m⁻³ (Figure 3b). Both TSS and turbidity measurements in the lagoon had dropped in the 12 months before the 2023 vegetation monitoring to levels of c. 2 g m⁻³ TSS and 2.5 NTU (Figure 3c). This reduction is possibly related to increased sediment trapping capacity of *Ruppia* plants with the development of vegetation (Section 5).

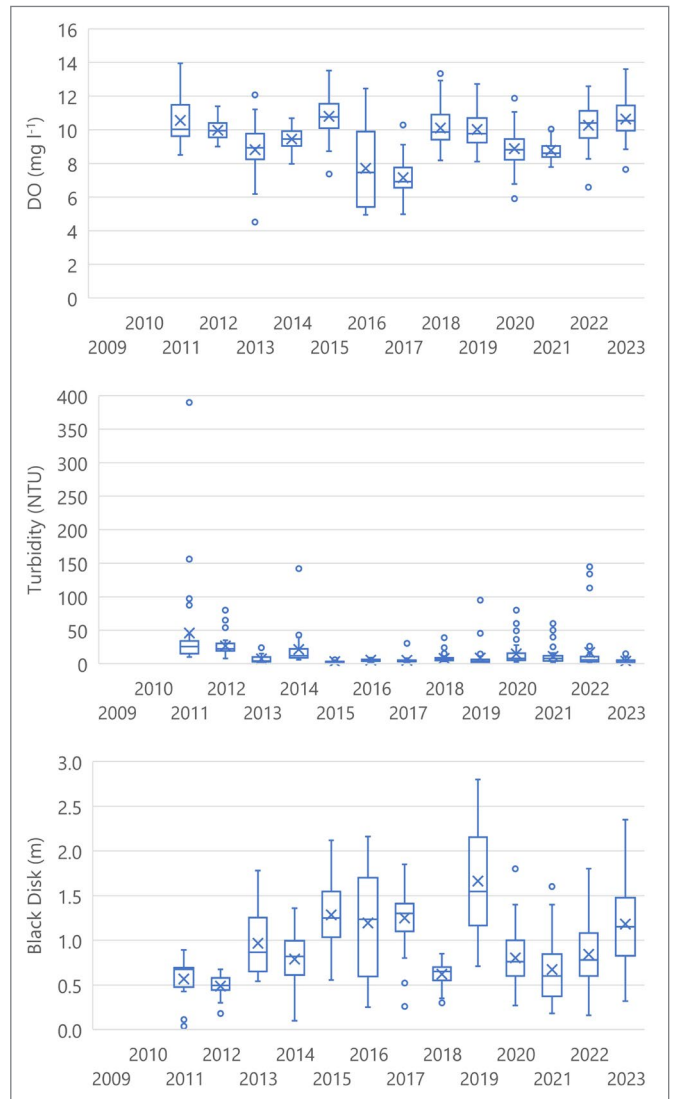
Figure 6: Box and whisker plots of DO (top), turbidity (middle) and black disk (bottom) at the monitoring sites (n = 47), from 2011 to 2023.

An average dissolved oxygen (DO) concentration of 10.6 mg l⁻¹ in 2023 was the second highest of all monitoring years (Figure 6). Dissolved oxygen levels were supersaturated at 83% of sites, likely due to very high *Ruppia* covers (Section 5) and only two sites recorded slightly less than 80% DO. The lowest recorded DO value was 7.6 mg l⁻¹ (Figure 6).

Average turbidity (NTU) was low in 2023 at a value of 3.9 (Figure 6). The highest turbidity measurements of c. 15 NTU were recorded in shallow water at two sites along the northern shoreline (Figure 4), possibly resulting from resuspension of bottom sediments by wind driven wave action.

Dense vegetation obscured black disc measurements at two sites in 2023. Elsewhere, the average black disc reading was 1.18 m (Figure 6). This value is similar to the monitoring years of 2015 to 2017, but lower than 2019 and higher than other years (Figure 6).

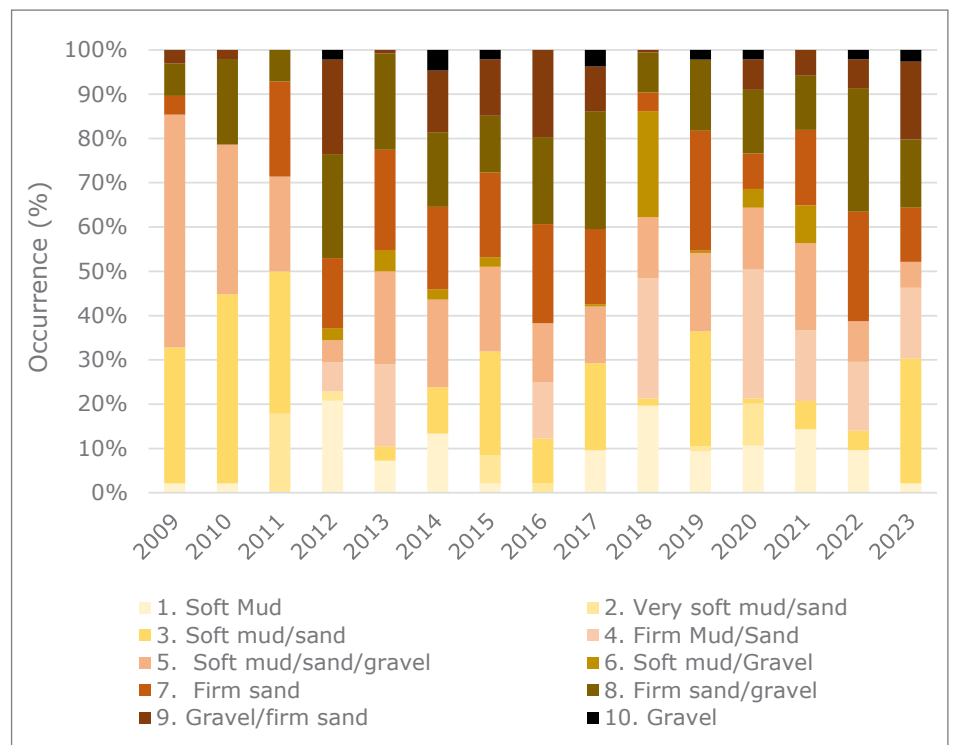
Figure 7: Bar plot illustrating the composition in substrate type (% occurrence), recorded during each of the annual monitoring surveys. Substrate types are numbered from softer to harder.

In 2023, the hoe substrates tended to be finer or softer (higher proportion of categories 1 to 3) than the previous year. The current monitoring year resembled the composition recorded in the monitoring years 2009–2011, 2015 and 2019, with a high proportion of soft mud/sand recorded (Figure 7). It also appeared that sand substrates had become muddier in 2023 than the previous year (Figure 7), potentially due to *Ruppia* capacity to trap suspended sediment and the increased vegetation development recently (Section 5).

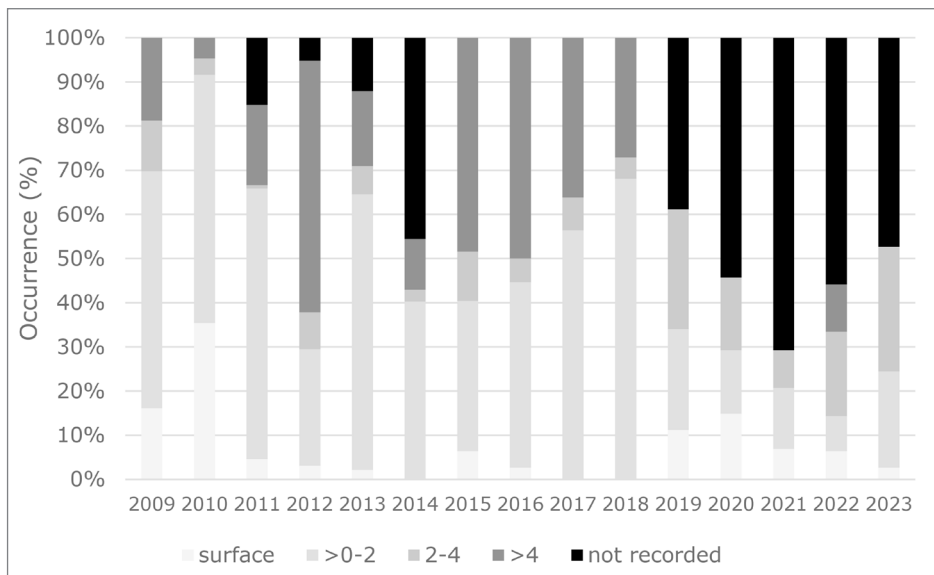
Figure 8: Substrate depth to a blackened layer shown as occurrence (% records) for five incremental depth categories.

A blackened layer at the sediment surface (<1 cm depth) was recorded at only 2.7% of sampled substrates in 2023 (Figure 8), all of which comprised fine sediment of sand to mud. This was the lowest proportion for this category recorded in the last five years of monitoring. Much higher proportions of blackened surface layers were recorded in 2009, 2010, 2015 and 2019 to 2022. However, greater than 50% of substrate samples in 2023 recorded a blackened layer within the top 6 cm of sediment, a proportion greater than the previous three monitoring years (Figure 8), which likely reflects a return to greater proportions of fine substrate.

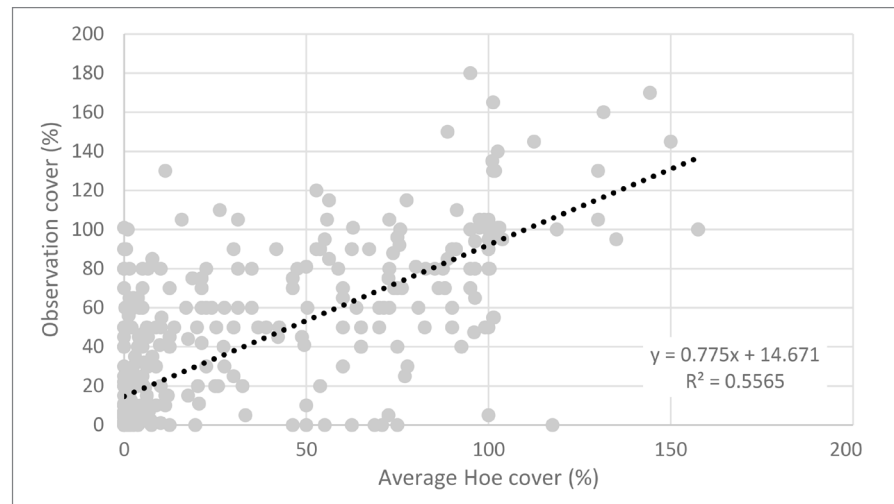
Figure 14: Relationship between macroalgal percentage cover estimated from hoe samples and diver observations within a 10 m diameter area at each site.

Dislodgment of algal cover has been observed when hoe samples were retrieved to the surface (e.g., Robertson and Stevens 2009, Stevens and Robertson 2010) and algal biomass has also been noted suspended in the water column by waves and currents and so not captured by the hoes. Therefore, an underestimation of macroalgal development is likely from hoe samples. However, diver observations over a 10 m diameter area at sampled sites in 2023 confirmed a low lagoon-wide average cover for macroalgae, with estimates of just 5.3%. The two measurements had a linear correlation ($R^2 = 0.89$) in 2023 (data not shown) that continued the relationship seen across all monitoring years (Figure 14). Average macroalgae cover for each method per monitoring year showed a closer correlation ($R^2 = 0.81$, data not shown), although the diver observations gave higher estimates than hoe measurements for 10 out of 11 years.
