**WETLANDS ON PRIVATE LAND IN THE WAITUNA
CATCHMENT, SOUTHLAND**

ECOLOGY, HYDROLOGY & WATER QUALITY

Prepared for Department of Conservation
September 2015 (finalised July 2017)

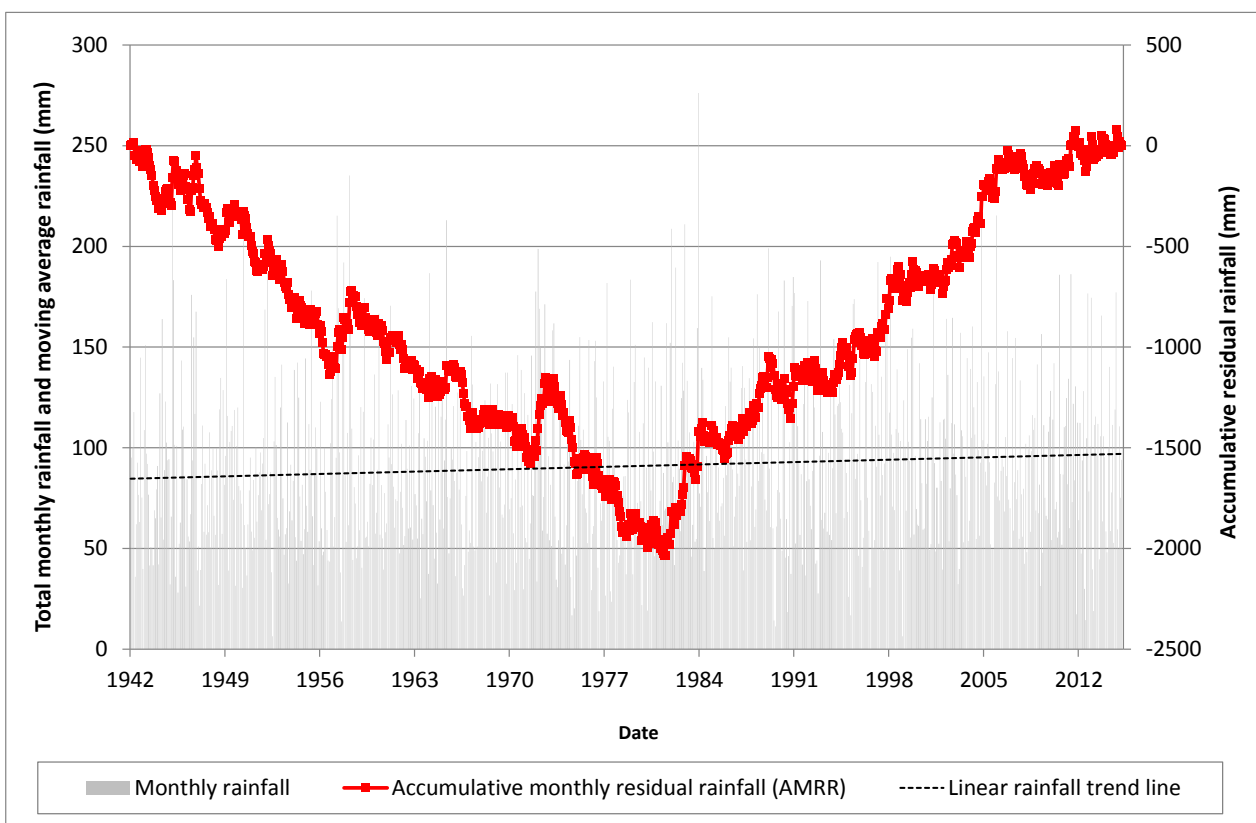
Figure 3-4: Monthly rainfall statistics for Invercargill (NIWA Agent Number 5814)

Accumulative monthly residual rainfall (AMRR) shows the cumulative deviation from the mean monthly rainfall. The AMRR from Invercargill shows below average monthly rainfall from 1942 to 1981 and above average monthly rainfall from 1982 through to 2015 (see Figure 3-4).

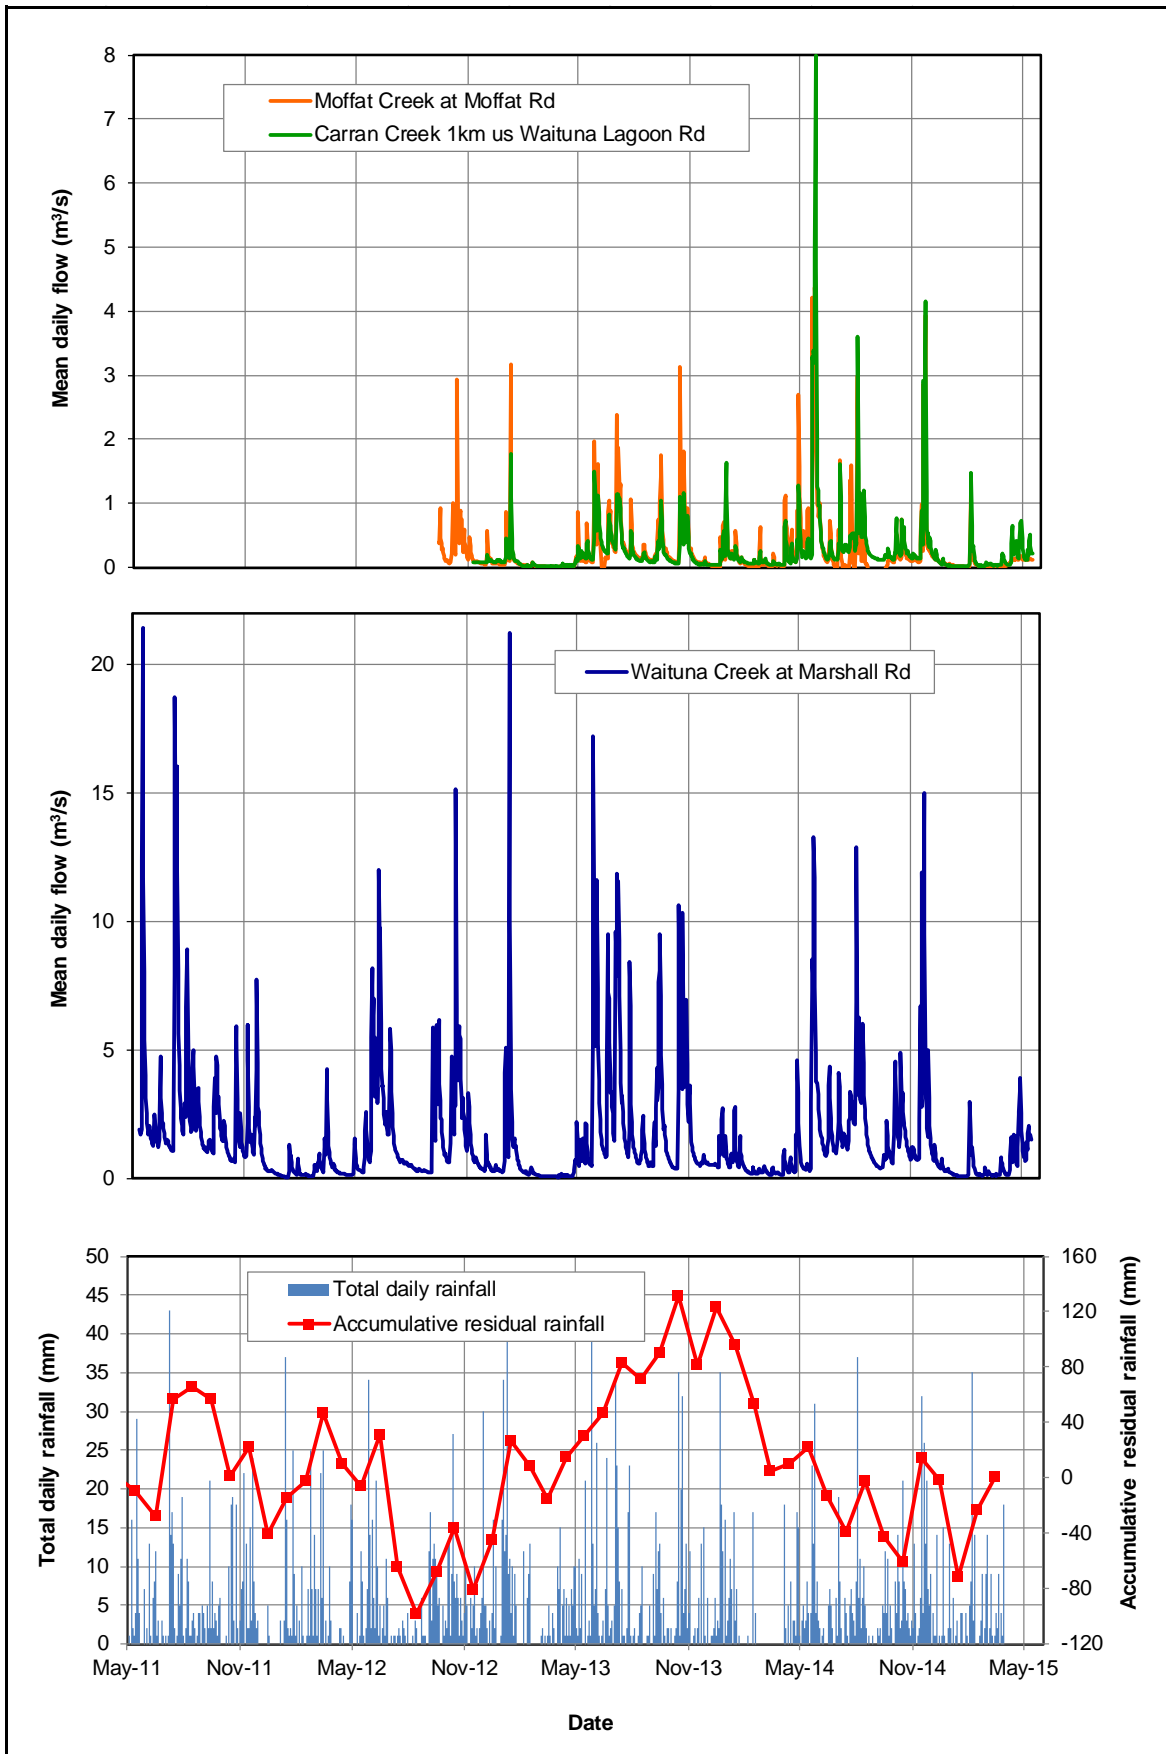
Figure 3-11: Mean daily stream flows versus rainfall since 2011 at Lawsons Road

One observation is that prior to about April 2014, Moffat Creek at Moffat Road appears to show a greater flow than Carran Creek 1km upstream of Waituna Lagoon Road. However Figure 3-11 shows that after April 2014, Carran Creek appears to have higher flows. The cause is not known but may warrant further investigation. From a visual observation of the data there appears to be no change in flows over time apart for Carran Creek or Waituna Creek but a possible decrease in Moffat Creek.
